Case Report

Unusual complication with an intramedullary lengthening device 15 months after implantation[☆]

The purpose of this case report was to present an unusual complication 15 months after implantation of an intramedullary lengthening device (PRECICE[®]).

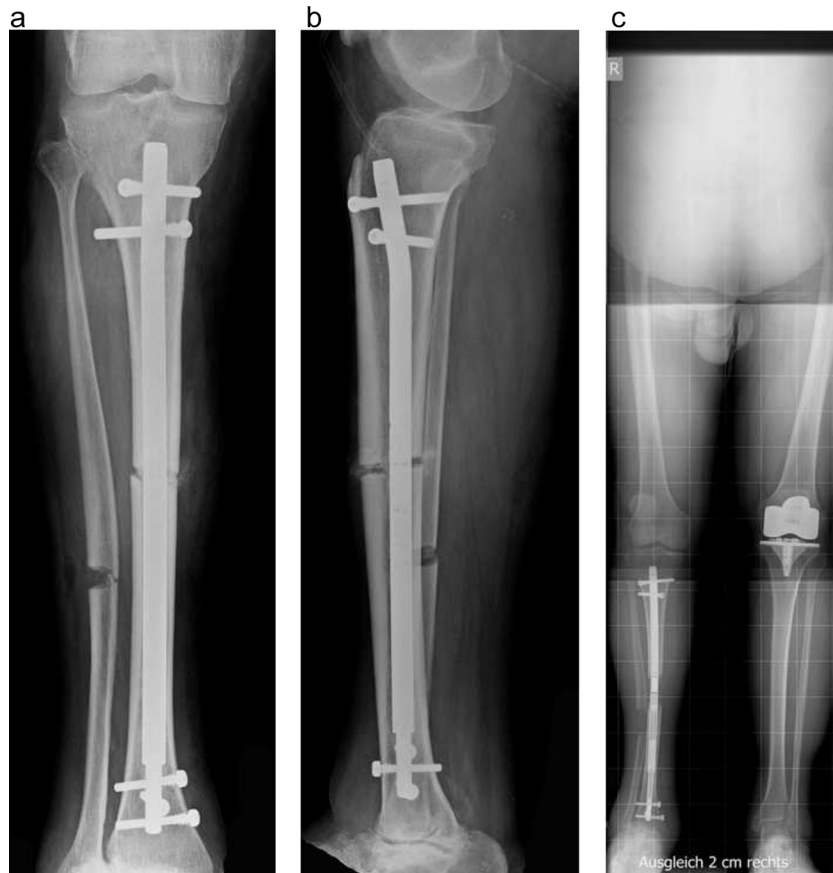
Fig. 1. (a–c) Radiographs of lengthening over time.

We are reporting a case of a 74 year old male patient with congenital malformation of the talus. Initially the patient presented with a limb length discrepancy of 6 cm at our outpatient deformity clinic in September 2013. Therefore in January 2014 a PRECICE[®] P1 nail was implanted in the right tibia because of congenital limb shortening. A single-level osteotomy was done at the centre of rotation and angulation due to an additional tibial valgus deformity of 10° in the midshaft. Distraction started intraoperatively (1 mm) to check the function of the telescopic nail radiologically (Fig. 1). In addition, bone graft harvested from the reamer heads were placed at the osteotomy side.

After he had reached the limb lengthening goal the follow-up visits were scheduled every two weeks according to the new callus formation. Initially, the patient ambulated non-weight bearing and increased to partial weight bearing (15–20 kg) at the end of the lengthening procedure. Full weight bearing was allowed 6 months after implantation, when callus formation had been clearly seen in the distraction gap. The tibia was lengthened 6 cm in total (1 mm distraction rate per day).

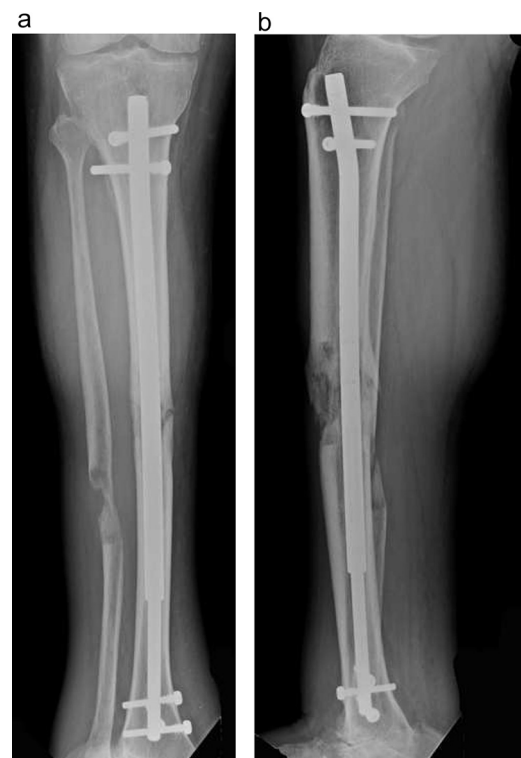
Fig. 2. (a, b) radiographs in lateral and a/p view with good callus formation after complete lengthening.

Five months after implantation the patient complained about a painful toe clawing which was operated. Afterwards the patient presented without any complications at the further follow-ups, showing radiologically obvious bony healing. At the end of the year, he was satisfied with his clinical result and was able to walk with a normal gait (Fig. 2).
