Morphology of small, discontinuous montane meadow streams in the Sierra Nevada

Michelle L. Slocombe^{*}, Jerry D. Davis^{*}

Department of Geography and Environment, San Francisco State University, 1600 Holloway Avenue, San Francisco, CA 94132, USA

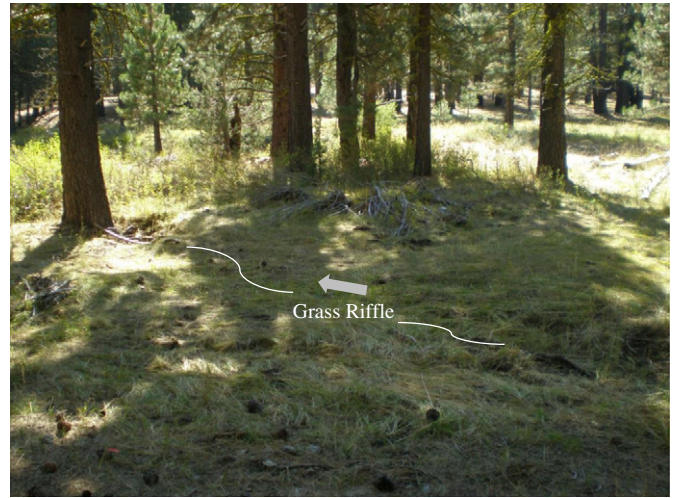
Fig. 1. Instead of riffles composed of coarse sediment, the meadow channels exhibit 'grass riffles', or stretches of grass sod connecting two scour holes, as seen in this photograph of Carman Creek in Three Corner Meadow. Gray arrow indicates direction of water flow during the wet season.

Many northern Sierra Nevada meadows are characterized by the presence of shallow, heavily vegetated stream channels that are almost indistinct, particularly when vegetation is thick during the summer months (Hagberg, 1995). In place of the classic gravel-bed entrenched channels typical of the American West, a key distinguishing feature of these meadow channels is the presence of a series of scour pools connected by grass sod. The resistant grass sod serves a similar energy-drop function as riffles or steps in typical alluvial systems (Fig. 1).
