A report on the fabrication of concrete pavement with the application of anionic bitumen emulsion

Michał Bołtryk^a, Krzysztof Falkowski^b, Edyta Pawluczuk^{a,*}

^b MARK-BUD Sp. z o.o. – Contractor Concrete Pavement of the Multimodal Reload Terminal, Białystok, Poland

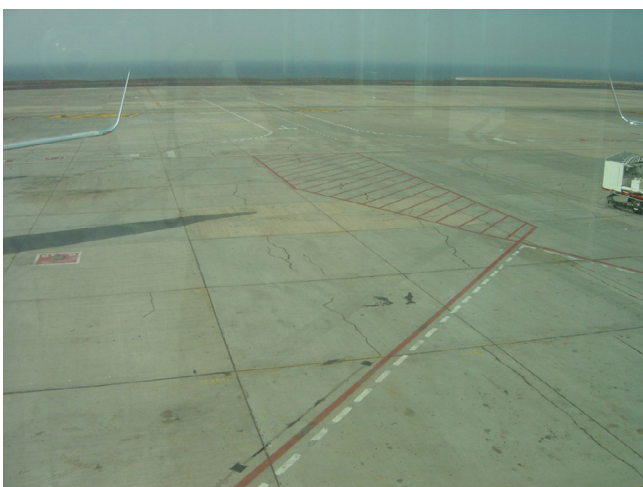
Fig. 1. Cracks in an airport apron – Airport Santa Cruze de Tenerife (photo. K. Falkowski).

the chief factors in environmental corrosion. In the example, Fig. 1, cracks in an airport apron can be seen caused by the insufficient stiffness of the concrete as well as the varying mechanical properties of the ground.

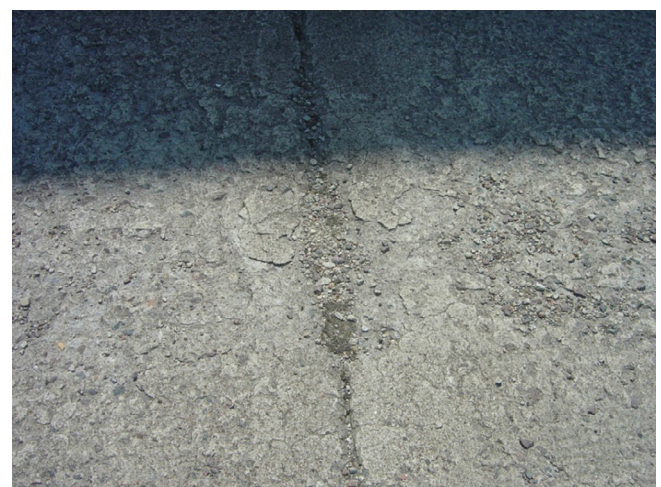
Fig. 2. The loss of the upper layer of concrete after a 20-year usage period (photo. K. Falkowski).

The next picture, Fig. 2, shows the loss of the upper layer of concrete after a 20-year usage period on a manoeuvring area on an industrial premises in Poland. The flaking of the concrete pavement is due to insufficient resistance to frost and the use of natural rounded aggregate.
