Repair of damaged end regions of PC beams using externally bonded FRP shear reinforcement

Ian Shaw, Bassem Andrawes*

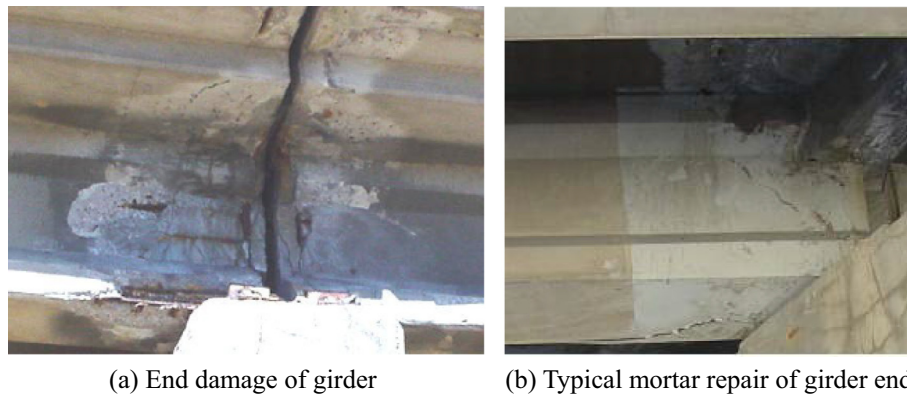
Fig. 1. End region damage and mortar repair of concrete bridge girder.

Mortar repairs are often used at beam's end regions to replace the damaged cover concrete caused by exposure to deicing salts and freeze/thaw cycling (Fig. 1b). While aesthetically restorative, a mortar repair alone may not be sufficient in restoring the original shear capacity and stiffness at the end of the beam.
