Diagnosis of electrocution: The application of scanning electron microscope and energy-dispersive X-ray spectroscopy in five cases

S.D. Visonà^{a,*}, Y. Chen^a, P. Bernardi^b, L. Andrello^c, A. Osculati^a^a Department of Public Health, Experimental and Forensic Medicine, University of Pavia, Via Forlanini 12, 27100 Pavia, Italy^b Department of Neurosciences, Biomedicine and Movement Sciences, University of Verona, Strada Le Grazie 8, 37134 Verona, Italy^c Service of Legal Medicine, Canton Ticino, Via Guisan 3, Bellinzona, Switzerland

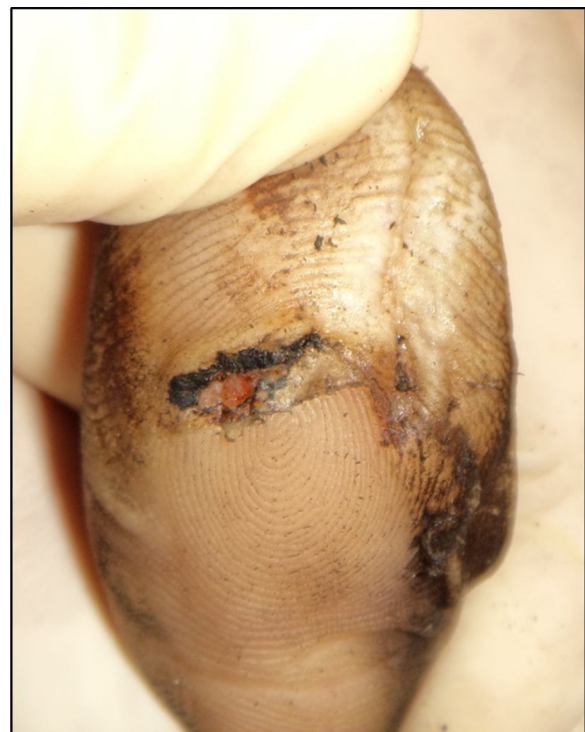
Fig. 1. Case 2, exit site.

A 41-year old male was found dead on the ground. The police records revealed that he was stealing the copper from a high voltage trellis (380 kV) and he might had accidentally touched the cables. (the cables were made of ACSR=“aluminum conductor steel reinforced”). Typical current marks were observed on his back and left gluteus and on his right hand (thumb and index). The autopsy revealed severe injuries due to the fall from height, namely subarachnoid hemorrhage, hemopericardium and hemothorax associated with pulmonary contusions, many lacerations at spleen and liver, with scarce blood infiltrates.
