Front blind spot crashes in Hong Kong

Yuk Ki Cheng*, Koon Hung Wong, Chi Hang Tao, Cheok Ning Tam, Yiu Yan Tam, Cheuk Nam Tsang

Forensic Science Division, Government Laboratory, 88 Chung Hau Street, Ho Man Tin, Kowloon, Hong Kong Special Administrative Region

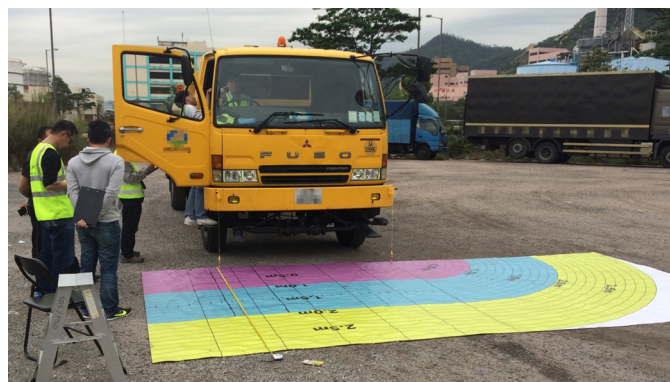
Fig. 1. The coloured plastic mat with grids used for measurement of field of view of the front blind spot mirror.

After the questionnaire, the details of the vehicles were recorded, and then examinations were conducted to determine any potential blind spots in front of the goods vehicles. A coloured plastic mat of 3 m by 6 m with dimensional grids was used to facilitate the measurements of the indirect field of view through the front blind spot mirrors. The plastic mat was put horizontally in front of the vehicle, and a pair of plumb bobs was hung from the two end of the front bumper to ensure proper alignment of the plastic mat. The grids on the mat mainly consisted of horizontal lines in front of the vehicles being measured with concentric quarter circles radiating from the nearside front corner at intervals of 0.1 m (Fig. 1).

The direct and indirect fields of view were measured with the examiner sitting on the driving seat with a 'normal' driving posture, e.g. sat upright with both hands on the steering wheel, then photos of the view through the front blind spot mirror of the plastic mat were taken whilst holding the camera at eye level to assess the coverage of ground level of the front blind spot mirror.
