Case study

Low carbonation of concrete found on 100-year-old bridges

Ivan Janotka^{a,*}, Michal Bačuvčík^a, Peter Paulík^b^a Building Testing and Research Institute, Bratislava, Slovakia^b Faculty of Civil Engineering, Slovak University of Technology, Bratislava, Slovakia

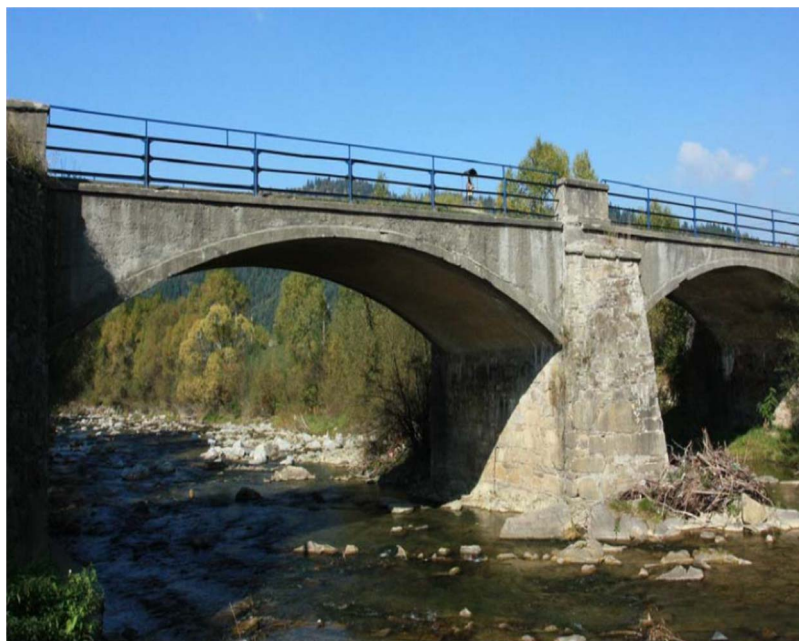
Fig. 1. Reinforced concrete bridge Krásno nad Kysucou before reconstruction in 2014.

The first investigated road bridge is situated above the river Bystrica in the city Krásno nad Kysucou. It is believed to be the oldest preserved reinforced concrete bridge in Slovakia and one of the oldest Monier Arches in Central Europe, which are still in service. The bridge was completed in 1892 as one of the series of Monier Arches built in the former Austrian-Hungarian monarchy. It has survived two World Wars without large damage and served till 2014 without any major repair. The bridge consists of two reinforced concrete arches built on stone abutments and stone pier, which were a part of the previous stone arch bridge. Each of arch has a span of 16.8 m and a span to raise ratio of 0.138 m. The thickness of primary arch varies from 400 mm in the springing to 150 mm in the crown of the first arch and only 130 mm at the crown of the second arch. Above the primary arch, which is reinforced at both surfaces, there is also an unreinforced overfill that reaches the thickness of up to 600 mm near the springing and gradually diminish towards the crown. Complete reconstruction of the bridge started in 2014 (Fig. 1) and finished in 2016 (Fig. 2). The carbonation depth was measured only by phenolphthalein test before and after reconstruction, when the origin concrete surface was covered by a modern covering plaster.
