Out-of-plane behavior of stone masonry walls: Experimental and numerical analysis

Aiming at contributing to the better understanding of the out-of-plane behavior of unreinforced stone masonry structures, this paper presents the results of an experimental and numerical campaign performed on two U-shaped walls with different masonry bonds representative of Portuguese vernacular architecture. The experimental campaign included non-destructive tests for the material characterization and an out-of-plane cyclic loading test for the characterization of the out-of-plane response. A finite element numerical model was constructed, calibrated with the experimental results, which allowed performing a nonlinear parametric study to evaluate the most influential material and geometrical parameters in the out-of-plane behavior of stone masonry walls.

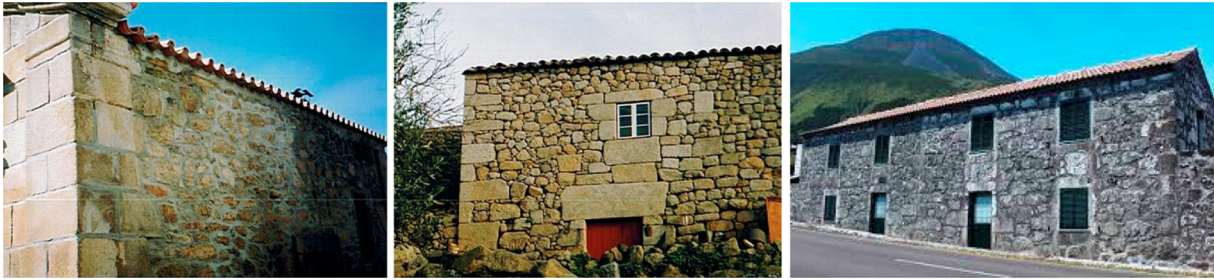
Fig. 1. Example of typical Portuguese stone masonry constructions.

Stone masonry is a traditional construction technique that can be observed in many regions throughout the world where stone is locally available. Many monuments and historical constructions were constructed in stone masonry, but also the vernacular buildings of many regions are frequently built with stone, see Fig. 1. Even though many of these examples have lasted until today, showing an outstanding endurance, stone masonry buildings typically show a poor performance when subjected to seismic actions,

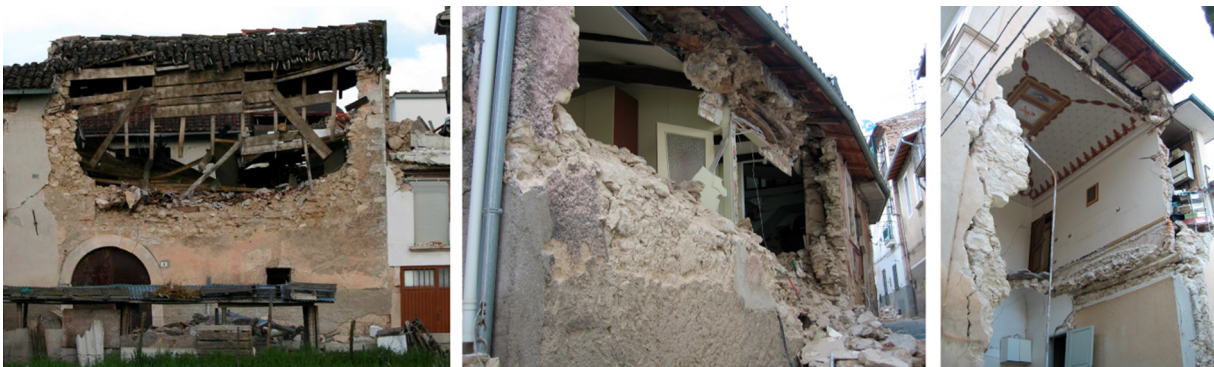
Fig. 2. Examples of common out-of-plane earthquake damage patterns in stone masonry buildings after 2009 L'Aquila earthquake.

Façade walls are usually the most vulnerable elements in stone masonry buildings precisely because of the previously noted lack of structural integrity due to a poor connection between structural elements, namely with the perpendicular walls and diaphragms. This is the reason why the out-of-plane collapse of the façade walls has been recurrently observed in past earthquakes [52,7,17,32,9,47,53,46,50,10,27]. Fig. 2 shows some of these typical out-of-plane collapses of the façade observed after 2009 L'Aquila earthquake in Italy.
