AE and Related NDT for Damage Evaluation of Civil Structures

Damage evaluation of an internal concrete in steel-plate bonded slabs with anchor-bolts

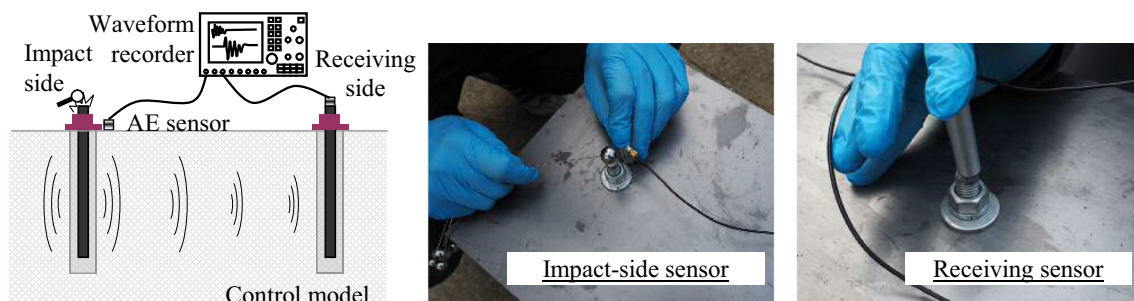
Fig. 3. Schematic diagram of measurement.

Fig. 3 shows the outline of the proposed anchor bolt sensing technique. An impact is driven by hammering the anchor-head with a steel ball of 15 mm diameter, and thus elastic waves are generated and propagate in concrete. The anchor-bolt is embedded about 20 mm in depth from the surface of the steel-plate. After elastic waves propagate from the impacted anchor, they are

detected and analyzed to evaluate the damage of internal concrete inside the RC slab. The sensor for detection is installed at the head of the anchor-bolt in the receiving side. To determine the excitation time, another sensor is installed on the surface of the steel-plate right next to the impact-side anchor bolt as shown in the figure.

Acoustic emission (AE) sensors (resonant frequency of 140 kHz) were used in the test for the measurement in both the impact and the receiving sides. At least, impacts were driven three times per one measurement, and a representative waveform was selected. Waveforms were recorded by the waveform recorder at a sampling rate of 0.2 μ s with the number of samplings of 25,000.
