Analysis on the mechanical properties of historical brick masonry after machinery demolition

Deniz Ucer^{a,*}, Aleksey Ulybin^b, Sergey Zubkov^b, Soofia Tahira Elias-Ozkan^a

The demolition process of a historical brick masonry building in St. Petersburg, Russia was observed as a case study and research was conducted on the possibility of reusing the resultant debris, which was composed of high quality brick masonry, as new building material. Therefore, samples from the demolition debris, i.e. brick, mortar and wall pieces were collected and tested for their mechanical properties, according to Russian standards, when available, and according to International Standards for the rest. The results for the compression test of brick and mortar separately as well as wall prisms indicated that their strength was still higher than standard limits, therefore, these wall pieces could be reused under appropriate conditions. Additionally, the bed mortar was tested under shear loads in order to understand if the jointing was still reliable or not. Eurocode 6 (Eurocode 6: Design of masonry structures – Part 1–1: General Rules for Reinforced and Unreinforced Masonry Structures, (2005)) defines a

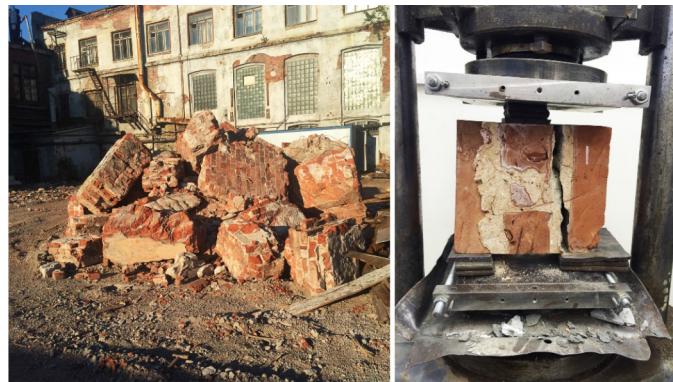
The process of the study: Investigation into the properties of debris, Laboratory tests.
