## Concrete durability issues due to temperature effects and aviation oil spillage at military airbase – A comprehensive review

Sukanta Kumer Shill<sup>a</sup>, Safat Al-Deen<sup>a,\*</sup>, Mahmud Ashraf<sup>a,b</sup><sup>a</sup> School of Engineering and Information Technology, The University of New South Wales, Canberra, Australia<sup>b</sup> School of Engineering, Deakin University, Waurin Ponds Campus, VIC 3216, Australia

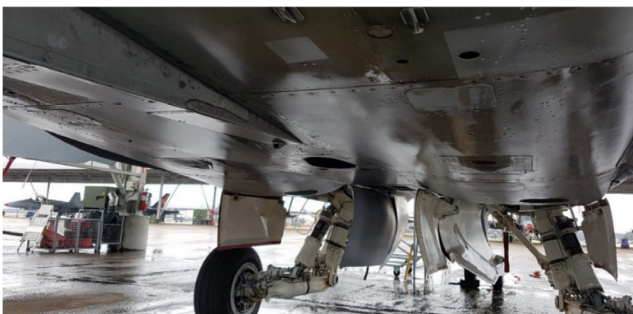
Fig. 1. Underbelly of an F/A-18 with APU featured in the centre of the photo [3].

Originally, most of the jet engines require an external starter motor to make the aircraft more self-sustaining. Auxiliary power units (APUs) have subsequently been added to many jet aircraft to make them more self-sufficient. APUs are essentially small jet engines that can be used to start the main engine and provide electrical and hydraulic power prior to starting the main engine start or providing power during an unexpected engine shut down. In most aircraft, the APUs exhaust is directed upwards or parallel to the ground surface. However, in the case of the F/A-18s and the B-1, the APU exhaust is directed downwards. These downward facing APUs exert the exhaust gas on the military airbase concrete at an angle of 45 °C, and measured surface temperature of concrete is approximately 175 °C [8]. Fig. 1 shows an APU at the bottom of an F/A-18, which is clearly visible in the centre of the photo.

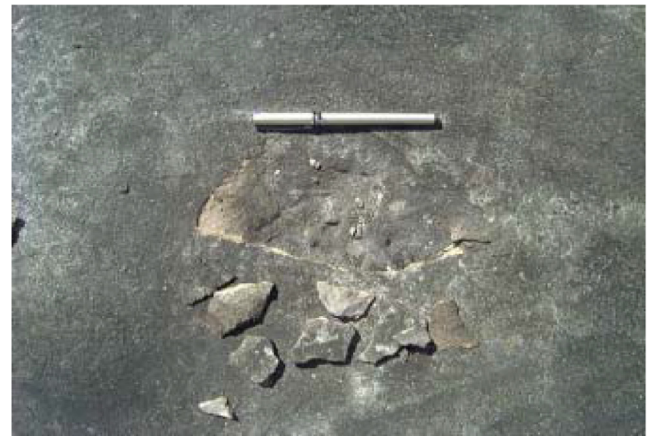
Fig. 2. Scaling at the top layer of the military airbase concrete.

Fig. 2 shows a scaling on the surface of a military airbase concrete. In the centre of Fig. 2, an old deep scaling is clearly visible, where aggregates were peeled off from the wearing surface of the concrete. This kind of damage is a source of FOD, and are observed more frequently in the vicinity of the APUs exhaust impinging the concrete. Additionally, a large amount of spilled engine oil, hydraulic fluid, and vented jet fuel from the aircraft are also found regularly in the same region of pavement where APUs exhaust impinges concrete. It is also to be noted that the jets usually park in roughly the same location every time, causing localised damage to some areas of aprons.
