An experimental study on the influence of composite materials used to reinforce masonry ring beams

Romina Sisti ^a, Marco Corradi ^{b,a,*}, Antonio Borri ^a

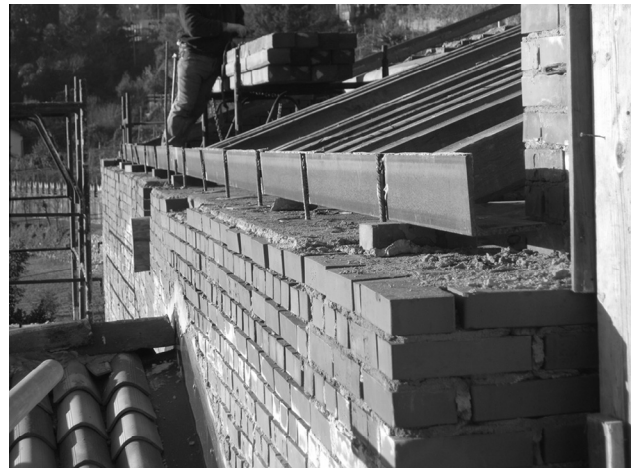
Fig. 4. Example of a steel-profile ring-beam.

Nowadays, it's usual to apply steel-profiles or masonry ring beams (Figs. 3 and 4). However, when a building is faced with stone, ring beams are made thinner than the wall so that they are screened and remain invisible on the façade. This kind of reinforcement is impossible when the thickness of the wall is small and it introduces an element which is extraneous to the existing structure.

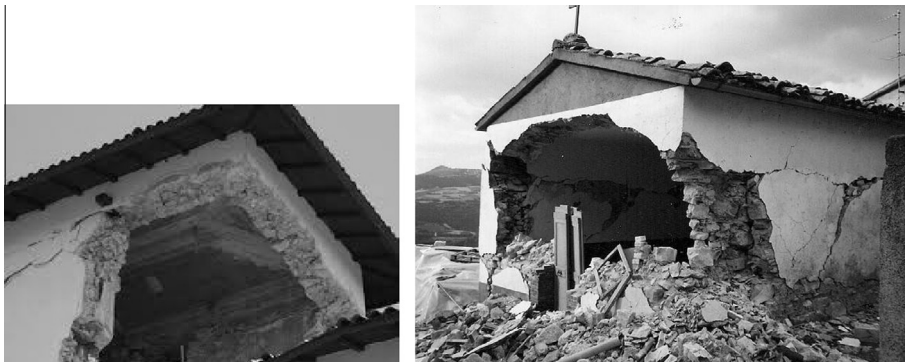
Fig. 2. Examples of an out-of-plane collapse due to poor connection between the RC ring beam and the underlying masonry.

Recent earthquakes have shown the limitations of new and more conventional techniques. For example the installation of RC ring beams has proved to be ineffective or to increase the seismic vulnerability of the construction when inadequately designed, not well connected to the existing masonry, when used on a poor masonry or in combination with heavy RC floors. It has been recognized by now that the greater stiffness of the RC ring beam compared to the stiffness of the masonry, produces a different response in these two materials during earthquakes and causes the load to be unevenly spread. In order to prevent out-of-plane collapse mechanisms, the action of vertical static loads may contribute to stabilize wall panels, but the application of stiff RC ring beam may cause the re-distribution of vertical compressive stresses and some portions of masonry could result unloaded and, during earthquakes, be prone to become unstable (Fig. 2) [6–8].
