Construction and Building Materials

Slot stitching for longitudinal joint separation repairs

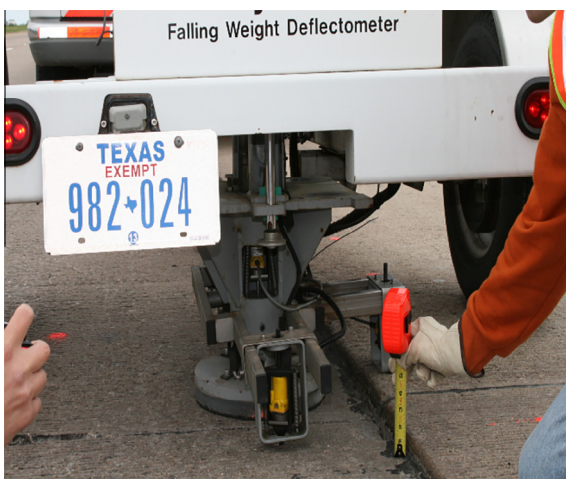
Fig. 1a. Faulting at longitudinal joint.

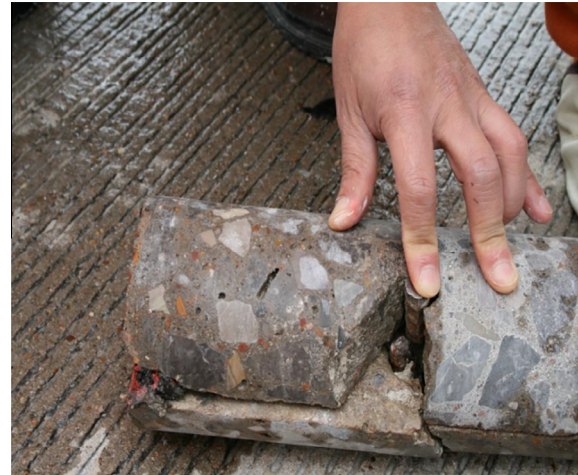
Fig. 1b. Shear failure of tie bar.

of tie bars subjected those bars to substantial stresses, especially when there are volume changes in base or subgrade layers, causing shear failures of those bars. Also, past construction practices of using L-shaped bars as tie bars to facilitate concrete placement, and bending those bars once concrete was hardened resulted in a higher frequency of shear failures of those bars. Deficient amount of tie bars and inadequate tie bar installation practices, along with volume changes or deteriorations in base or subgrade layers, resulted in lane separations. Once tie bars are broken at longitudinal joints, the probability of lane separations becomes high. Large openings at longitudinal joints are detrimental to pavement performance in two ways. One is letting water get into the pavement system, potentially degrading base or subgrade layer, especially if base layer is not stabilized. The other is the loss of load transfer efficiency (LTE) across joints. LTE at longitudinal joints is not as critical as LTE at transverse contraction joints; however, wandering of trucks could place concrete slabs with failed tie bars at edge loading condition, rather than at interior condition, increasing wheel load stresses substantially and thus reducing the fatigue life of the pavement. Moreover, loss of LTE due to failed tie bars could cause faulting at longitudinal joints as illustrated in Fig. 1a, which shows that a faulting as much as 51 mm (2 in.) occurred. A core was taken at this joint and, as expected, a tie bar was broken as shown in Fig. 1b. Fig. 1c shows the inside of the core hole, indicating that this is a longitudinal construction joint and there was a lane separation. Distresses observed in this pavement section included various types of cracking, including transverse, corner and diagonal cracking, as shown in Fig. 1d.

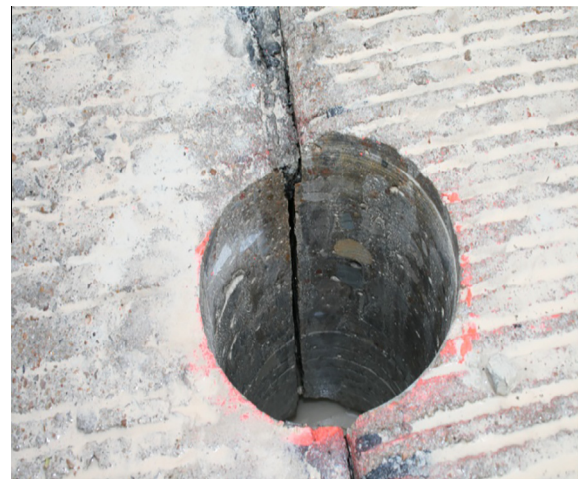
Fig. 1c. Lane separation at longitudinal construction joint.
