# Performance of 90-year-old concrete in a historical structure

Won-Chang Choi<sup>a</sup>, Miguel Picornell<sup>b</sup>, Sameer Hamoush<sup>b,\*</sup>

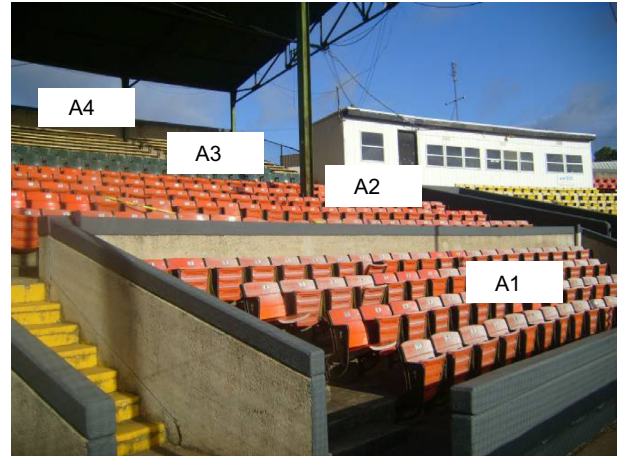
**Fig. 2.** Seating slab.

As presented in the earlier assessment [1], the overall condition of the aged concrete in the historical structure presented 'very poor' conditions, including cracking, scaling, rebar corrosion, carbonation, spalling of concrete, etc. However, the assessments were local and thereby restricted a thorough assessment of the overall performance of the aged concrete and determination of the degradation of the aged concrete.

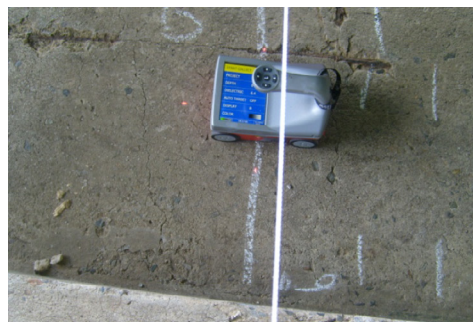
(a) GPR test equipment (SSM)

The work for this assessment focused on two areas of the stadium. The first is a façade tower and the second is a section of the seating slab. First, visual inspections were conducted for these two areas, and the two nondestructive test devices (GPR and PSPA) were used to scan the overall area. The GPR unit used in this study is the StructureScan™ Mini (SSM) shown in Fig. 1(a). It is a compact, lightweight, handheld

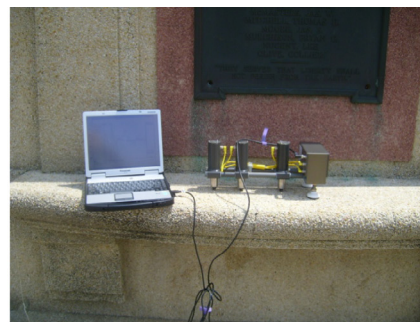
(b) PSPA test equipment

In this study, two nondestructive methods, a ground penetrating radar (GPR) device and a portable seismic property analyzer (PSPA) in combination with impact echo and ultrasonic surface wave technology, were employed to determine the properties of the aged concrete in the overall area of a seating slab in the stadium. The nondestructive test results were compared to laboratory test results obtained from core samples.
