Performance of structural insulated panels with rigid skins subjected to windborne debris impacts – Experimental investigations

Tianjin University and Curtin University Joint Research Center of Structural Monitoring and Protection, School of Civil and Mechanical Engineering, Curtin University, Kent Street, Bentley, WA 6102, Australia

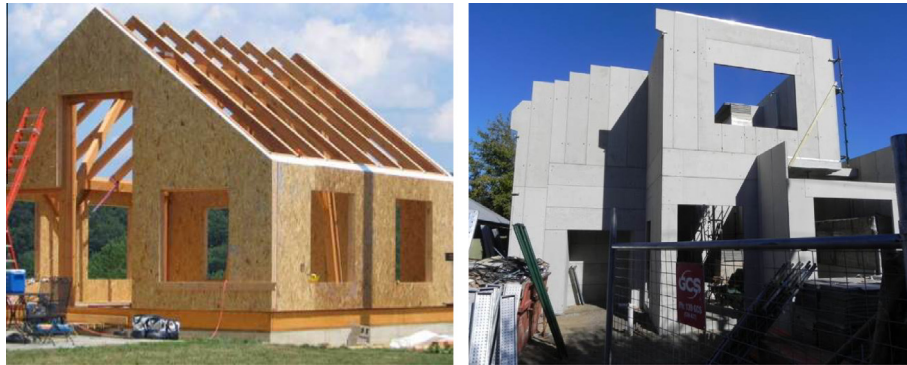
Fig. 1. (L) SIP house with OSB skin [7]; (R) SIP house with fiber cement skin [7].

Modular building is becoming increasingly popular around the world due to its affordability, energy efficiency and sustainability. Structural insulated panel (SIP) is a prefabricated engineered lightweight building material which can be used in the modular building as a principal load bearing component such as exterior wall, framing, partition wall, roof, floor and structural framing. SIP is recognized as an efficient panel in the construction industry due to its advantages of being environmentally sustainable, economical, easy to install, ultra-lightweight, high strength to weight ratio, thermal insulated, moisture resistant, acoustic insulated, termite resistance, and flame retardant [1]. SIP consists of a rigid insulating

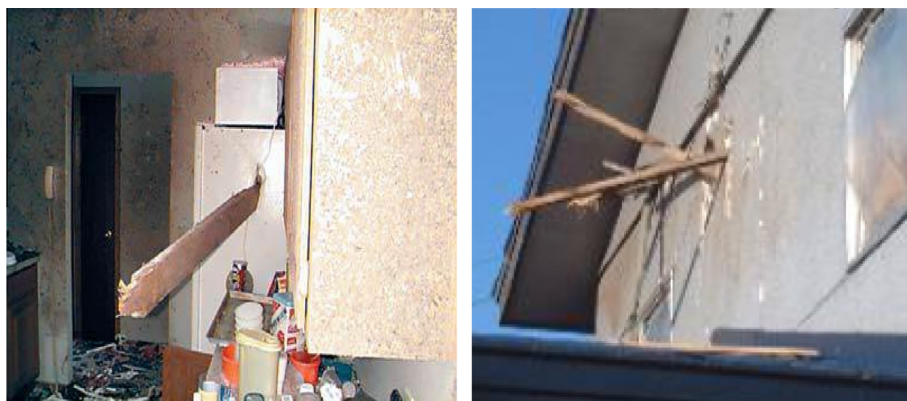
Fig. 2. (L) Windborne missile penetrating a refrigerator in Midwest tornadoes (1999) [16]; (R) windborne missile penetrating a wall [17].

Cyclone intensity and occurrence increase every year with the climate change. The post storm investigations found that cyclone generated enormous amount of windborne debris and the windborne debris impact was highlighted as a major cause of damage to building envelope [8], as shown in Fig. 2. The windborne debris penetration through building envelope typically creates a dominant opening, which results in a differential internal pressurization that contributes to the increased loading of the building's roof and leeward walls, ultimately may lead to entire roof lifting up or even collapsing [9]. Therefore, it is important to understand the penetration resistance capacity of SIPs, especially when they are used in the regions prone to cyclones as failure is directly related to structural integrity and safety [10]. To withstand the impact of such extreme event, the penetration resistance capacity of wall or roof panels to windborne debris impact should satisfy the testing requirements specified in the respective design codes such as the Australian Wind Loading Code (AS/NZS 1170.2:2011) clause 2.5.8 [11]. Impact tests can be carried out using available facilities such as pendulum and air cannon, etc. [12–15].
