In-situ assessment of physical performance and degradation analysis of rendering walls

A. Menezes, M. Glória Gomes*, I. Flores-Colen

Department of Civil Engineering, Architecture and Georesources, Instituto Superior Técnico, Universidade de Lisboa, Av. Rovisco Pais, 1049-001 Lisbon, Portugal

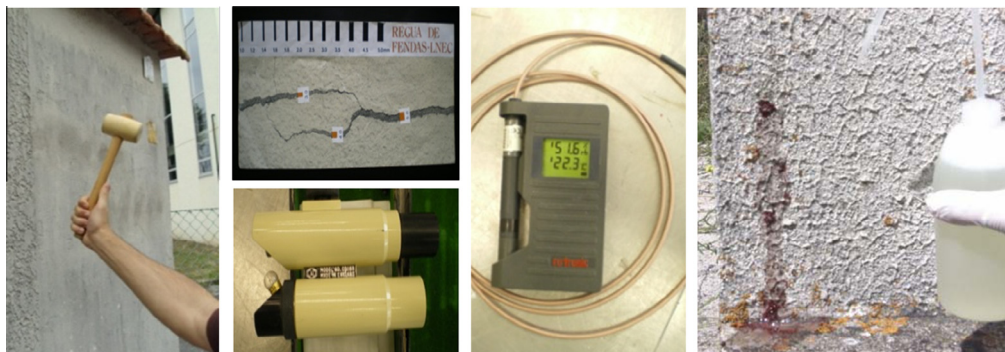
Fig. 1. Example of expedient tools used: from left: hammer tapping; crack width microscope measure (down) and crack width gauge (up); thermo-hygrometer; sodium hypochlorite solution.

In this study, nondestructive techniques are used on field inspections. These techniques allowed the proposal of an inspection methodology to evaluate in-situ physical performance of renders, starting from a visual inspection with expedient techniques such as hammer, compass, level, among others (Fig. 1), followed by infrared thermography, Karsten tube and moisture meter for a more accurate evaluation in localized areas (Fig. 2).
