# The change in selected properties of ceramic materials obtained from ceramic brick treated by the sulphate and chloride ions

Teresa Stryszewska \*

Cracow University of Technology, Department of Institute of Building Materials and Structures, Faculty of Civil Engineering, Warszawska st. 24, 31-155 Cracow, Poland

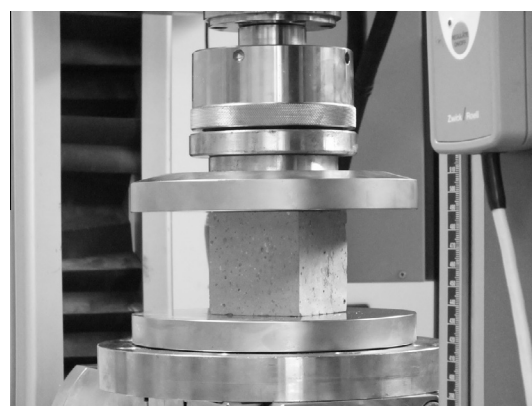
**Fig. 1.** The compressive strength test.

forming element. The load speed was  $1 \text{ MPa/s}$ . The compressive strength test was performed on the dried samples, after each subsequent exposure of 5 cycles. The obtained results were the average of 15 determinations. Fig. 1 shows a method of testing the compressive strength.

The compressive strength test was performed in a universal testing machine Zwick 1200. The load was applied parallel to the

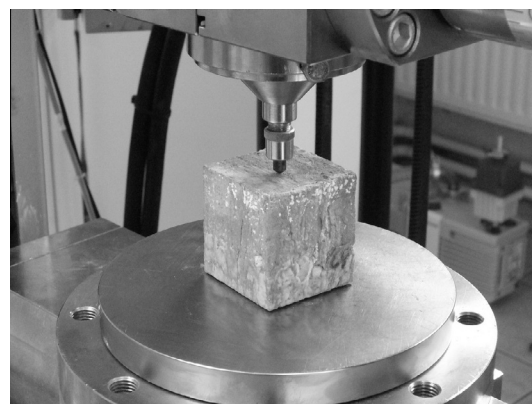
**Fig. 2.** The hardness test.

The surface hardness test was performed in a universal testing machine Zwick Z100 equipped with a Rockwell indenter with the diamond cone. The indenter entered into the test pieces at a constant speed of  $1 \text{ mm/min}$ . After entering the indenter to a predetermined
