## Review

## Rising damp removal from historical masonries: A still open challenge

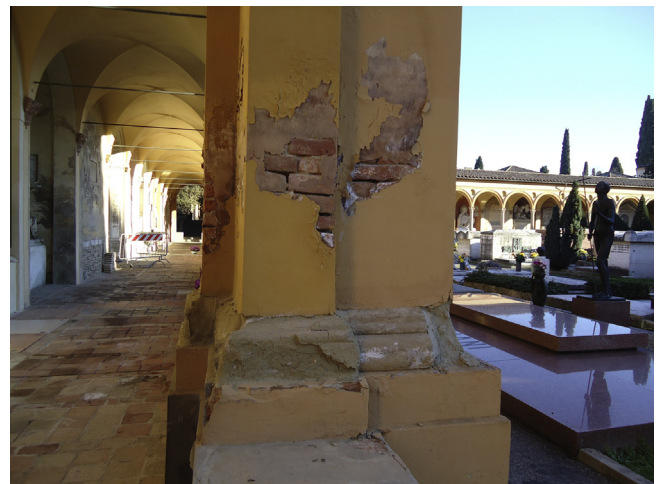
**Fig. 1.** Persistent problems connected to rising damp in a recently restored part of the Monumental Certosa Cemetery in Bologna, Italy (XIX Cent.). Salt-rich moisture evaporates mainly through the most permeable material (sandstone base) leading to stone decay, and also causes the paint detachment.

Despite this, the removal of rising damp from historical masonries still remains extremely challenging, and the owners of historical buildings, the authorities in charge of their conservation and the conservation practitioners are still short of reliable solutions for the dehumidification of masonries and disoriented in coping with this issue. As a result, current restoration (or simply refurbishing) works are often carried out without any intervention for moisture removal and the materials decay and defects reappear after short time. As a matter of fact, if the main degradation cause is not removed, any intervention on materials is useless and further works will be soon necessary (Fig. 1).
