Repairs of longitudinal joint separations and their performances

Dar Hao Chen*

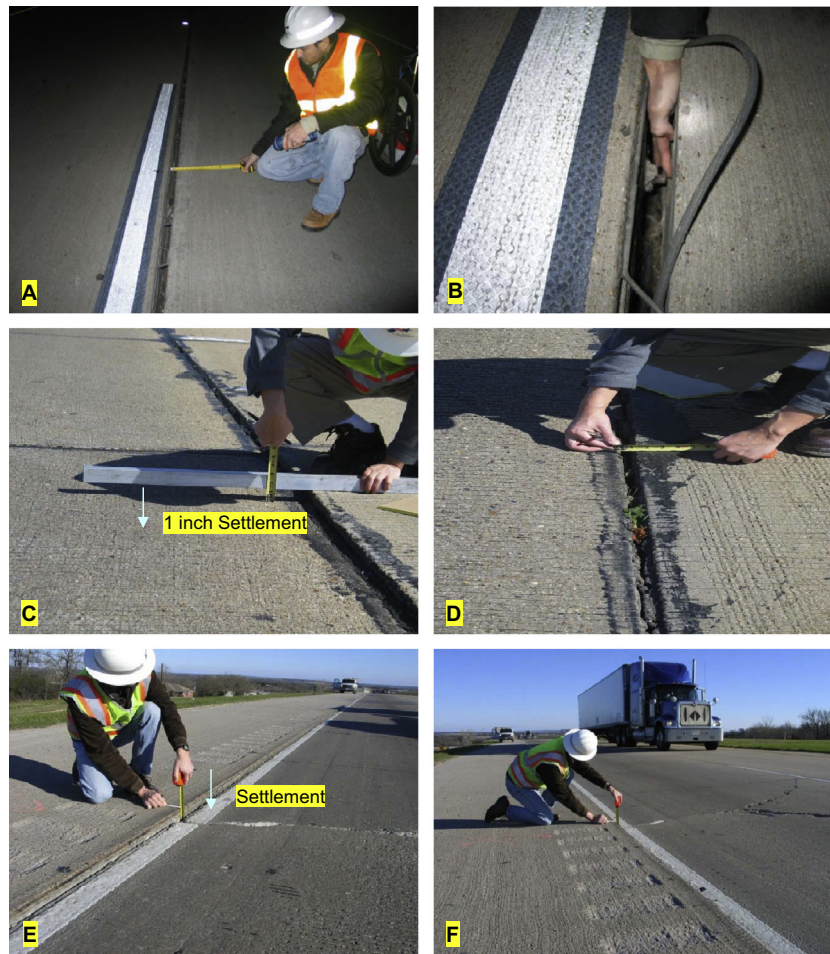
Fig. 1. Typical examples of lane separation, faulted and shattered slabs. (A) and (B) Lane separation for IH35. (C) and (D) Faulted JCP slabs on US59-Atlanta district. (E) and (F) Faulted and shatter JCP slabs on US75-Paris district.

Over the last 40 years, Texas Department of Transportation (TxDOT) districts have reported longitudinal joint separations and slab faulting in both Continuously Reinforced Concrete Pavement (CRCP) and Jointed Concrete Pavement (JCP), as shown in Fig. 1. The undesirable joint separation at the longitudinal construction joint has often led to further structural deterioration of the pavement. In addition, joint separation and slab faulting creates a safety hazard. Many miles of CRCP and JCP in Texas currently suffer distresses due to the absence or ineffectiveness of tie bars at longitudinal construction joints. The absence or ineffectiveness of tie bars causes larger deflections of concrete slabs and pumping, ultimately resulting in lane separation, cracking and faulting of

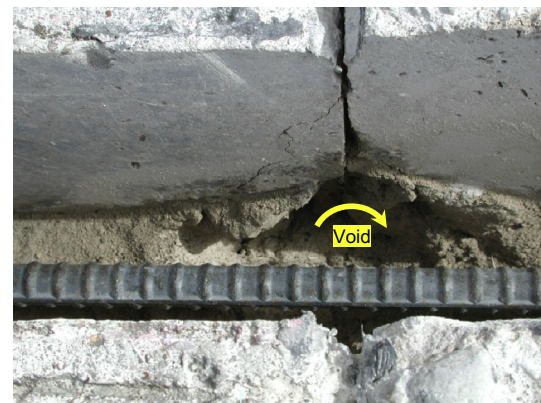
Fig. 3. Void and cracks near the joint.

slab faulting. Field observation indicated that poor LTE and settlement is typically associated with pumping, which creates voids under the joints and concrete slabs, as shown in Fig. 3.
