Internal environment in the museum building—Assessment and improvement of air exchange and its impact on energy demand for heating

Joanna Ferdyn-Grygierek*, Andrzej Baranowski

Department of Heating, Ventilation and Dust Removal Technology, Silesian University of Technology, Konarskiego 20, 44-100 Gliwice, Poland

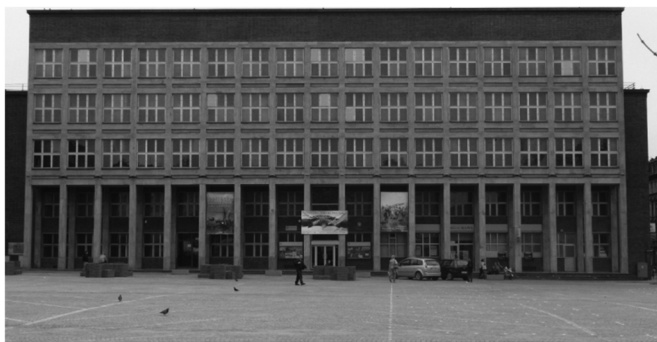
Fig. 1. The museum building selected for the analysis.

The museum located in Upper Silesia of Poland was selected for the analyses. It is double-winged five-storey building erected in 1929–1930 and was specially designed for exhibition purposes. The main entrance is in the west part of building (Fig. 1). The exhibition rooms are located on the first, second and third floors. The total exhibition area amounts to: 250 m² (Flora&Fauna exhibition) and
