Parameter identification for damaged condition investigation on masonry arch bridges using a Bayesian approach

B. Conde^{a,*}, P. Eguía^b, G.E. Stavroulakis^c, E. Granada^b

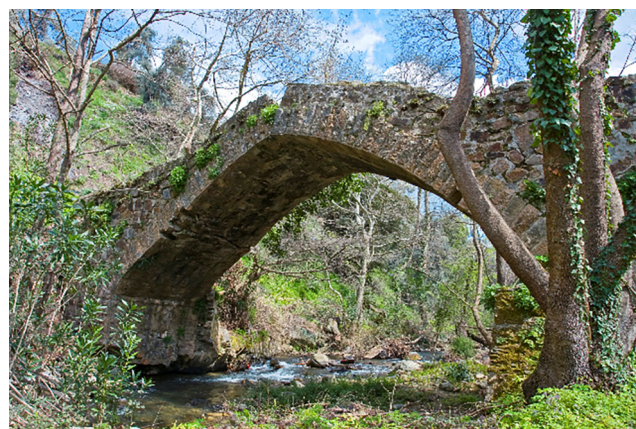
Fig. 1. Kakodiki Bridge: general view from the downstream side [4,5].

The proposed methodology has been applied on a real masonry arch bridge located in Kakodiki village, on the island of Crete in Greece (see Fig. 1). The bridge was built in 1903 by the Cretan State and its heritage importance was officially recognized by the Greek government in 2005.

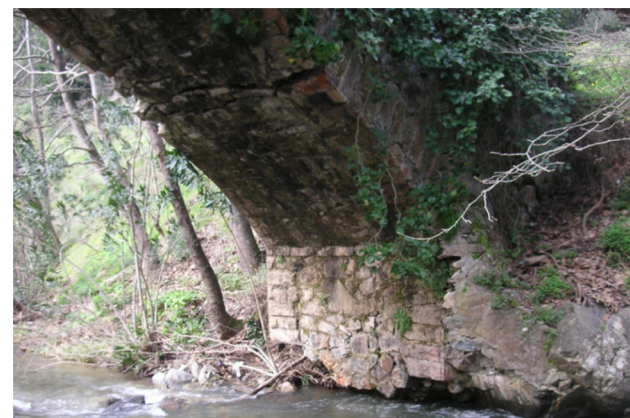
Fig. 3. Kakodiki Bridge: damage in one of the abutments, shown from the upstream side [4,5].

together with the presence of a significant deterioration at the abutments (Fig. 3). The cracks are placed approximately at a quarter of the span from both sides of abutments (hinge 1 and 3) and at the crown of the arch (hinge 2).
