# Degradation laws of hysteretic behaviour for historical timber buildings based on pseudo-static tests

This paper reports on the pseudo-static tests (PSTs) with a single storey full-scale timber building with architectural details that are prevailing in the Song dynasty, China (A.D. 960–1279). The PSTs were conducted under three levels of vertical load. The force and displacement relationship at selected points in the backbone curves were analysed for the structural stiffness and the accumulated energy dissipation with varying ductility coefficient. The degradation ratios of the bearing capacity, lateral stiffness, and the accumulated energy dissipation of the structure under different vertical loads were obtained. The trilinear backbone curve in PST1 is different from the bilinear relationship in PST2. The stiffness degradation can be modelled with a power function while it is accompanied with a reduced maximum accumulated energy dissipation.

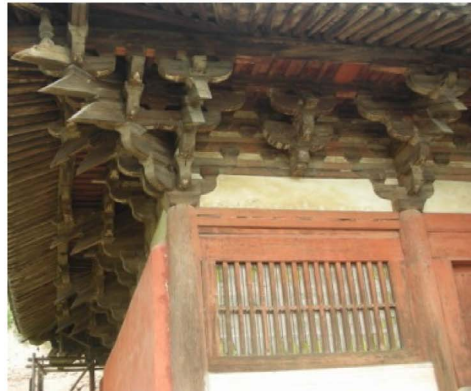
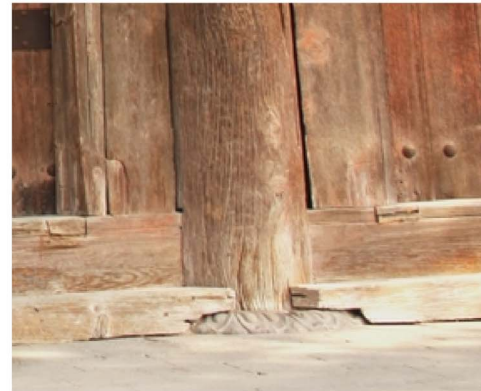
Fig. 1. Components of the Chinese traditional building.

(a) Front View

(b) Building body

(c) Column foot

A historical Chinese timber building can be divided into three zones along the vertical direction: stylobate, building body, and the roof (Fig. 1(a)). Stylobates are the structures below the column foot including the stone bases and foundation. The building body refers to that part above the column foot and below the eaves consisting of the column frames and *dou-gong* sets (bucket arches), or storeys (Fig. 1(b)). The roof is above the eaves and is composed of roof trusses and the roof covering. Generally, the column foot is directly placed on the stone bases (Fig. 1(c)).
