NDT&E International

Holographic subsurface radar for diagnostics of cryogenic fuel tank thermal insulation of space vehicles [☆]

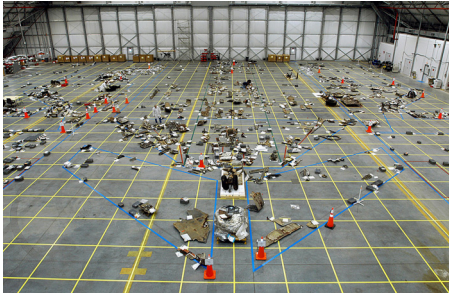
Fig. 2. Result of *Columbia* disaster on February 1, 2003. Remains of the spaceship collected on the ground were laid out in a hangar.

The Space Shuttle *Columbia* disaster occurred on February 1, 2003, killing all seven crew members, Figs. 1,2. This and other incidents which fortunately did not lead to such catastrophic consequences have aroused interest in the development of new methods for non-destructive testing of insulation and thermal protection coatings on spacecraft and fuel tanks [1–4].

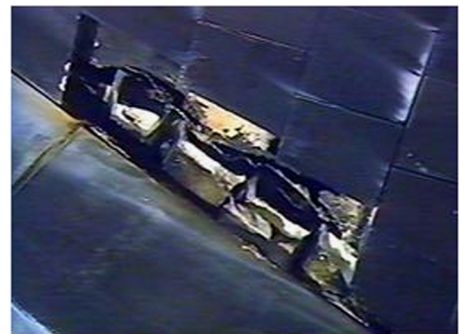
Fig. 6. Destruction of three the tiles placed directly behind 21st section of the wing leading edge of spacecraft *Buran* [6].

It is well-known that the tiled thermal protection coating of return vehicles such as the Space Shuttle is exposed to high mechanical, and especially thermal, influence on reentry. In fact, after the first flight of *Columbia* (April 12, 1981) 16 tiles were lost and 148 tiles were damaged [5]. Similar problems with more serious after-effects arose after the first and only flight of *Buran* (November 15, 1988). Post-flight inspection showed partial destruction to complete loss of thermal shielding tiles, Fig. 6 [3]. Such damage could lead to a repeat of the *Columbia* disaster in future missions.
