ICESD 2014: February 19-21, Singapore

Redevelopment of Old Sludge Reservoirs

Because of environmental and societal constraints Tessenderlo Chemie at Ham is reorganizing its sludge deposit sites, covering more than 200 ha in the area. Due to changing production and organization, some of the deposits are being closed and the sites redeveloped, whereas other deposits are reorganized. This paper deals with the problems, occurring at the treatment and reuse of the specific industrial sludge as a construction material for dikes.

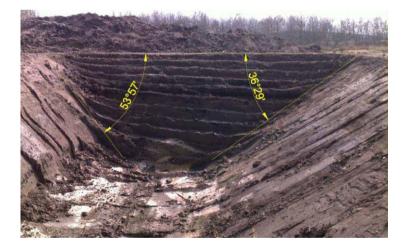
Fig. 1. Test excavation at Old Deposit

The Old Deposit was inactive for the last 30 years. In this period the sludge was naturally dewatered and consolidated. However, the unknown characteristics of the material presented a risk during the removal works, and therefore, a test excavation was made inside the deposit area to evaluate the sludge conditions and the stability of the sludge slopes during excavation. The test pit measured $27 \times 20 \text{ m}^2$, with a depth of 8 m. Two slopes were profiled, one with an angle of 36° , the other with an angle of 53° (Fig. 1). After one month there were no indications of slope instability or sliding. A computer model confirmed the stability of the test pit both for short-term and long-term safety. Therefrom, it was concluded that an excavation under a gradient of 53° could be executed safely.
