# Shaking table tests on seismic response and damage mode of tunnel linings in diverse tunnel-void interaction states

Tunnel engineering  
Shaking table test  
Void-lining interaction  
Seismic response

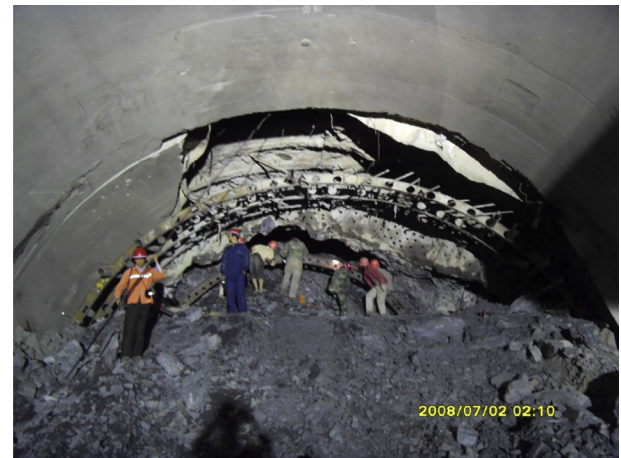
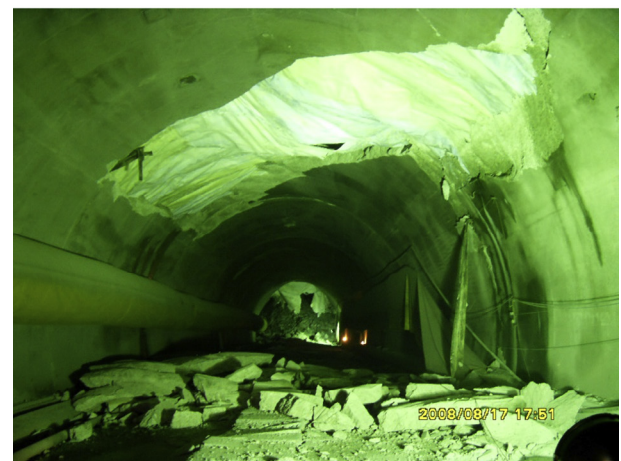
Fig. 1. Damage modes of Longxi tunnel with voids on its crown in Wenchuan Great Earthquake 2008, China. (a) Void-inducing lining crown collapse in constructing stage; (b) Void-inducing lining crown collapse in operating period.

To date, many transport tunnels have been unavoidably constructed in seismic fortification zones and voids concealing areas. Fig. 1 shows the damage patterns of tunnel structures with voids on its crown after Wenchuan Great Earthquake (Wang et al., 2015). Thus, it is of great significance to study the seismic damage mechanism of tunnel linings with voids defects, which is helpful to protect serviceability of transport tunnels under and after earthquake attack. Herein, this research aims to study the seismic response and damage patterns of tunnel linings in diverse tunnel-void interaction states. Thereby we had designed and conducted a series of shaking table tests on lining models with voids on lining crowns. Technical details of the tests including test facilities, experimental setup, soil and lining models, design and fabrication of the soil container and simulations of seismic excitations are presented in this paper. The results obtained in this study may provide useful references for researching the failure mechanism, preventing and repairing methods for void-inducing defects of tunnel structures.
