Engineering Science and Technology, an International Journal

Scour depth at inclined bridge piers along a straight path: A laboratory study

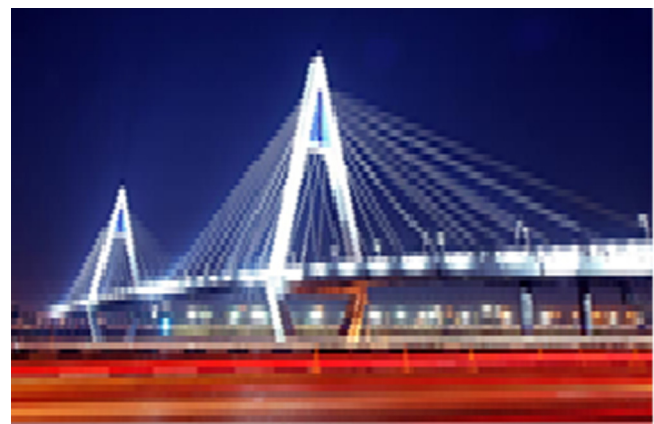
Fig. 1. The Eight Bridge with inclined piers, built in Ahvaz, Iran [18].

Technological advancements have made possible the construction of bridges with inclined piers in different parts of the world including in Ahvaz, Iran (The Eight Bridge shown in Fig. 1). Since no other study than that by Buzkus and Cesme [17] has so far been conducted on scouring around inclined piers, the authors decided to study this phenomenon in the laboratory.
