# Analysis of an explosion accident at Danyang Power Plant in Hubei, China: Causes and lessons learned

On August 11, 2016, an explosion of a high-pressure steam pipeline occurred at a power plant in Danyang City, Hubei Province, China. The accident killed 22 people and 4 people were injured. The causal factors of the accident were analyzed to prevent such catastrophe in the future. The entire accident process was divided into three sequential events for respective analysis based on timeline. Furthermore, a new model demonstrating the relationships among different causal factors was proposed and applied for this accident analysis. With respect to the power plant, the deficiencies from five causal categories were identified, which clearly demonstrated the accident mechanism from immediate causes to root causes. The results of the analysis indicated that unsafe acts performed by staff from different levels in power plant led to unsafe conditions, which were due to three factors, i.e., staff's inadequate safety knowledge, weak safety awareness and bad safety habits. The elements in safety management system (e.g., “procurement,” “determination of applicable legal requirements and other

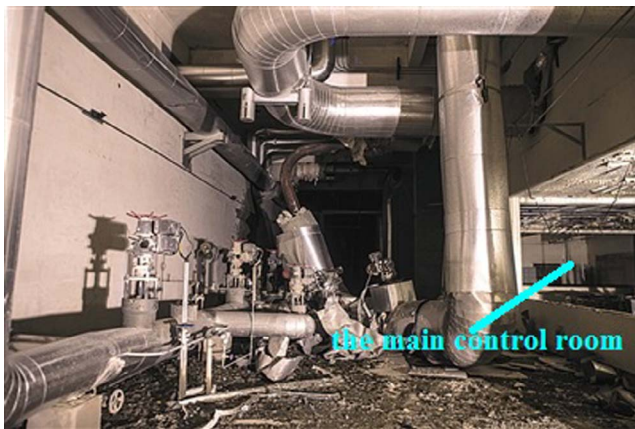
Fig. 1. Scene of steam pipeline explosion (Xinhua Net, 2016).

The cracked steam pipeline was located in a room on the third floor of a plant building where massive steam pipelines were arranged; and the main control room was next door, separated by a piece of double-pane glass. The investigation indicated that the cracked location was the weld in the flowmeter of the main steam pipeline which was located in the steam outlet of the No. 2 boiler (Hubei Provincial Safety Production Supervision Authority, 2017; Xinhua Net, 2016). When the explosion occurred, there were operators and managers in the main control room who were killed and injured by the explosion's shock wave and leaked hot steam with the temperature of 530 °C; moreover, the explosion caused damage to the facilities (Hubei Provincial Safety Production Supervision Authority, 2017; Office of Work Safety Committee, 2016; Xinhua Net, 2016). Figs. 1 and 2 show the photographs of the accident scene.

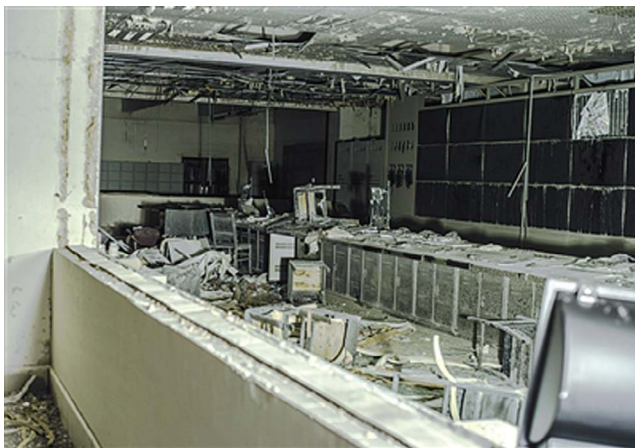
Fig. 2. Scene of the main control room after explosion (Xinhua Net, 2016).
