Ceramic insulators coated with titanium dioxide films: Properties and self-cleaning performance

Juan G. Castaño^{a,*}, Esteban Velilla^b, Lorena Correa^a, Maryory Gómez^a, Félix Echeverría^a

^a CIDEMAT, Universidad de Antioquia UdeA, Medellín, Colombia

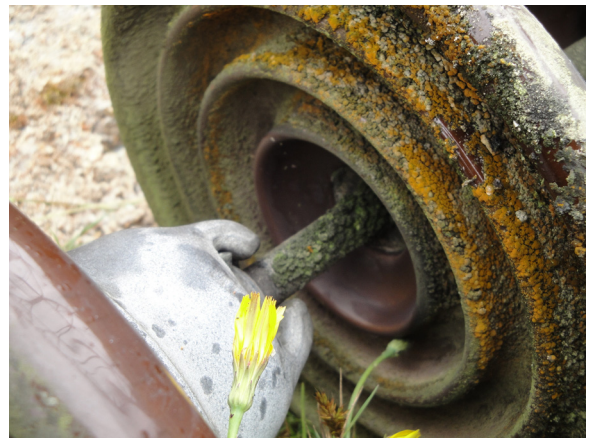
Fig. 1. Biological soiling of insulator in Balsillas.

For the field exposure, two power transmission towers located in sites with different types of soiling were selected. In both sites, strings of insulators with and without coating were installed horizontally, and a visual assessment of individual insulators was done after five months of exposure. The first site, called Balsillas, is rural and has high humidity and strong wind currents, which facilitates the growth of biological type organic pollutants, mainly algae. The second site, called Calera, is also rural, although soiling occurs primarily because of its proximity to a cement factory that emits significant amounts of particulate matter. Both tropical-humid sites have high soiling rates. Insulators installed in such sites must be replaced after one year or less. Fig. 1 shows an insulator, fully covered with biological soiling, retired after 9 months in Balsillas (before installation of coated insulators).
