Engineering Failure Analysis

Performance-based assessment of multi-story unreinforced masonry buildings: The case of historical Khatib School in Erzurum, Turkey

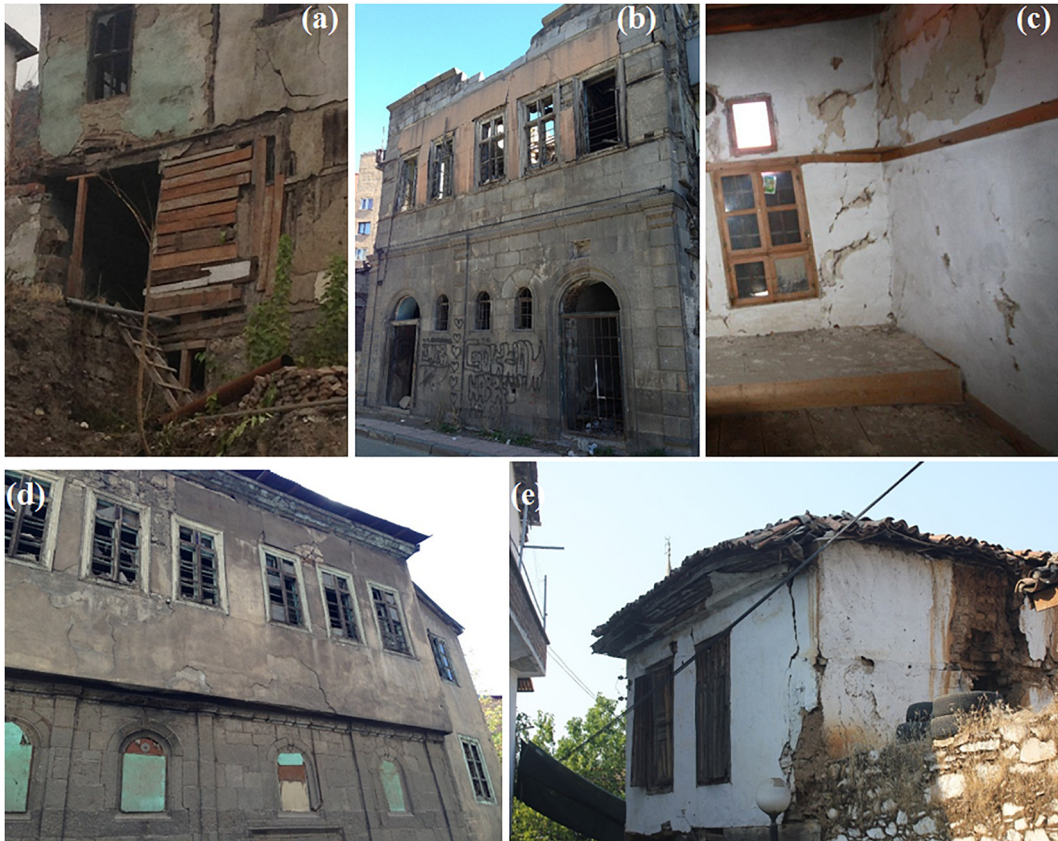
Fig. 1. Typical structural failures of the URM buildings in Turkey after earthquakes (a) Partial collapse in stone masonry walls of the ground floor, (b) Wall-diaphragm tension tie failure, (c) Spalling of masonry unit faceshells and vertical cracking at toe regions, (d) Spandrel joint sliding problem, (e) Vertical cracks at the corners of the masonry wall.

Masonry structures composed of brittle materials such as stones and bricks that have little under tensile and compressive stresses due to their engineering properties. In other words, under tensile and pressure effects, they suddenly migrate without plastic deformation. Particularly, due to tensile stresses formed in the masonry walls, some cracks occur on the wall. On the inner walls, this behavior and cracking patterns are typical and an expected situation in the URM buildings. Another important parameter that leads to the damage of the URM buildings is shear force. Since the limited shear capacity of the masonry materials is easily exceeded under seismic loads, the masonry walls begin to crack easily. After first cracking and damage, the load bearing capacity of the masonry walls decreases suddenly, which causes local collapses in the structure. This situation makes the URM structures highly vulnerable to seismic loads (Fig. 1).
