Failure analysis of centrifugal pump impeller

This paper analyzed the looseness failure between impeller and shaft. In order to determine the cause of the failure, the torque produced by external loads was calculated theoretically. The torque capacity of interference connection was analyzed using finite element method (FEM). The basic mechanical properties of different impeller were tested and applied to the FEM model to find out the influence of mechanical properties on interference connection between impeller and shaft. The analysis results indicate that interference connection condition is greatly affected by mechanical properties. The torque capacity of interference connection decreases with the mechanical properties decrease. The maximum torque transmitted by interference connection being lower than resultant resistance torque is the main reason of looseness failure between impeller and shaft.

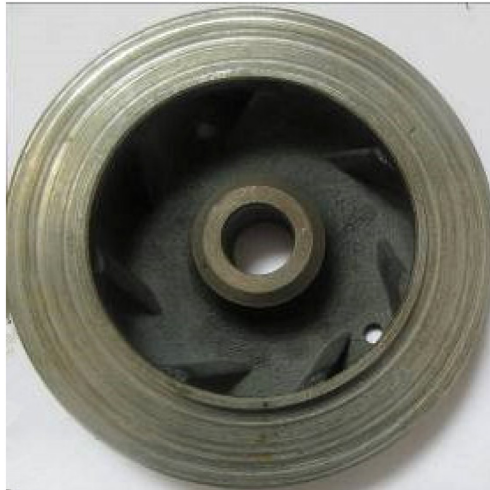
Fig. 1. Wear scar of impeller.

In the process of diesel engine test, several engines showed high temperature warning of water temperature. By disassembling the pumps, the failures of pump are presented. Some of the interference connections between impeller and pump shaft are loosen. There is friction and wear between impeller conical surface and pump case during rated working condition due to axial force. However, the wear scar of impeller in circumferential direction is particularly deep as shown in Fig. 1. Also there are some foreign metal bodies attached in the pump case, as shown in Fig. 2.

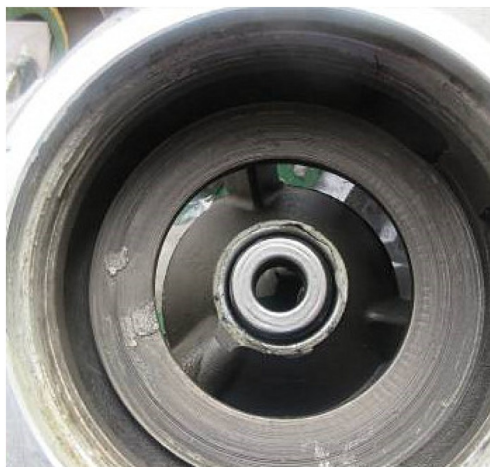
Fig. 2. Foreign metal bodies' location.
