Investigation of the binding materials properties and assessment of durability issue in Fasil Ghibbi palace in Gondar

ABSTRACT

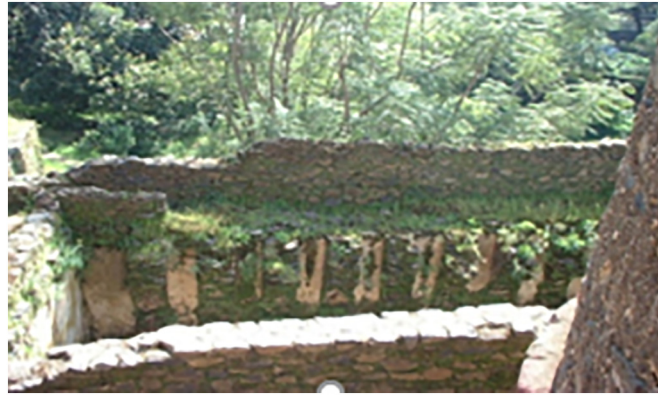
Fig. 1. Buildings in good condition.

The Royal compound lying within 700 m.sq., it encompasses six lofty castles and many different purposed buildings like the royal archive, house of the musicians, the lion cage, the horse zoo, the sauna bath, house of the spinners etc. The earliest and grandest of all edifices is that of Emperor Fasiladas, which is 32 m high and with battlemented square tower (Bureau 2011). Today, these historical structures are in different physical state, some are in relatively good condition, while many are in a deplorable state (see Figs. 1 and 2).

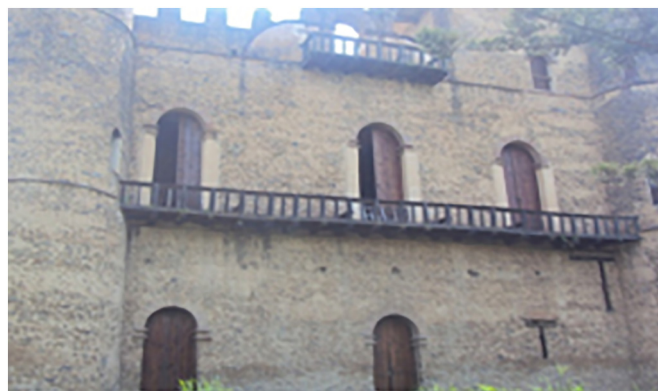
Fig. 2. Buildings in deplorable state.
