# Contribution of humidity to the degradation of façade claddings in current buildings

Clara Pereira<sup>a</sup>, Jorge de Brito<sup>b,\*</sup>, José D. Silvestre<sup>b</sup>

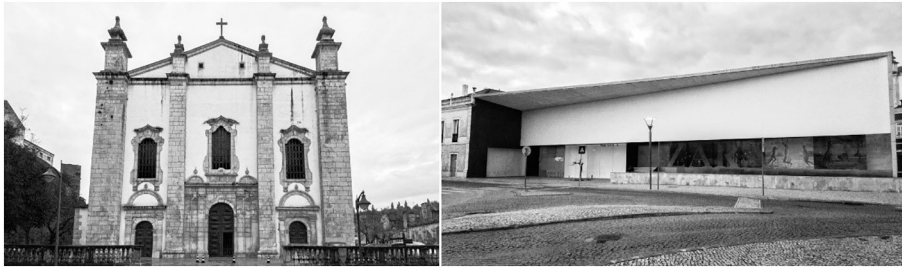
Fig. 1. Example of an historic building with various protrusions intended to protect the façade from the water flow (left) and a contemporary building with a single protrusion that is effective in protecting the façade from humidity-related issues (right).

As stated by Mostafavi and Leatherbarrow [20], to some extent, humidity effects on claddings can be seen as a surface modification often classified as aesthetic deterioration, resulting in “sightly” (i.e. pleasant to look at) or “unsightly” buildings. This aesthetic deterioration on façades corresponds, essentially, to the effects of rainwater on materials, accentuated by the inadequate provision of projections to lead the downward flow of water, such as sills, copings or downpipes, unpopular in recent “flat” façades. The effects are more visible in more porous materials, as limestone and concrete, resulting in a dramatic change in the overall appearance of the building. In fact, historic buildings (Fig. 1, left) used to have abundant ornaments that protrude beyond the surface and function as drips, projecting the rainwater and preventing the deposition of water on the façade. As the architectural trends evolved, as seen in Fig. 1 (right), these dripping ornaments were removed, bringing the need of new sealants [20].
