## Effect of electrical discharge machining on corrosion and corrosion fatigue behavior of aluminum alloys

Saravanan R. Arunachalam<sup>a</sup>, Sarah E. Galyon Dorman<sup>a,\*</sup>, Richard T. Buckley<sup>a</sup>, N. Aidan Conrad<sup>b</sup>, Scott A. Fawaz<sup>a</sup>

Electrical discharge machining (EDM) is often used in the manufacturing of fatigue test coupons because it allows for the production of complex shapes and sharp starting notches. However, the effect that the machining process has on the corrosion susceptibility due to the surface alterations is unknown. This work focuses on the effect the machining method has on the corrosion and corrosion fatigue behavior of aluminum alloys. The study is aimed at understanding the influence of EDM processes on environmentally assisted cracking evaluations, namely crack growth rate. Conventional milling and electrical discharge machining were the machining process examined in this study; the machining parameters used were best practices for laboratory fatigue sample production. The following aluminum alloys (AA) 2024-T351, 5083-H116, 6061-T6 and 7075-T651 were evaluated in this study. EDM was performed using a 0.152 mm (0.006 in.

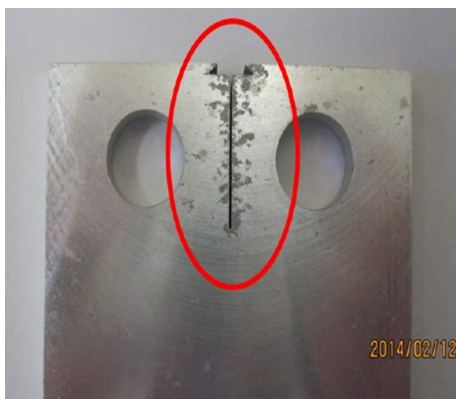
Fig. 1. C(T) specimen after two months outdoor exposure at Daytona Beach.

During an outdoor exposure at the Battelle Outdoor Exposure Facility in Daytona Beach, FL, a 5083-H116 aluminum alloy compact tension sample (C(T)) exhibited corrosion damage near the notch, Fig. 1. The notch on the sample had been electrical discharge machined (EDM), while the other sample surfaces had been milled. Based on a visual examination of the sample, it appeared that the 5083-H116 test coupon suffered corrosion damage on the surface adjacent to the EDM notch, while the milled surface was not affected as severely by the environment. The ellipse in Fig. 1 highlights the accelerated corrosion around the EDM notch. Accelerated corrosion around an EDM notch on a laboratory fatigue specimen raises concerns about the impact of manufacturing methods on corrosion performance, and in turn environmentally assisted crack growth testing. Such preferential corrosion damage on a critical location of a test specimen could produce error in damage predictions or material properties based on laboratory testing of specimens.
