## International Journal of Pressure Vessels and Piping

## Seismic fragility of threaded Tee-joint connections in piping systems

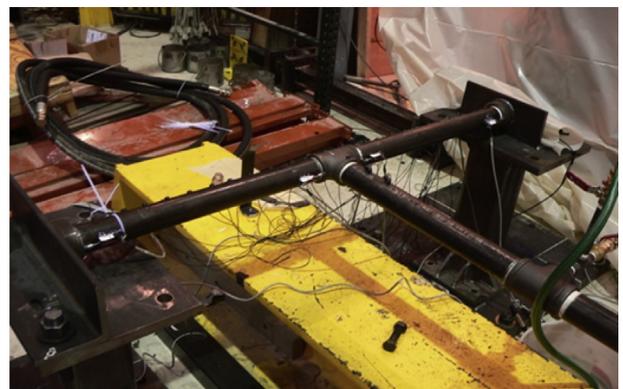
Fig. 1 shows the actual test set-up for determining the force-displacement and moment–rotation relationships of the threaded Tee-joint connection under monotonic and cyclic loading conditions. As seen in this figure, the loading was applied as an in-plane force loading at the bottom of the Tee-joint. The test-setup was built in such a way that the Tee-joint can be displaced in both forward and reverse directions along the “bottom of the T”, an axis perpendicular to the center of the Tee-joint, as shown in Fig. 1. Also, the ends of the pipes connected to the flange of the Tee-joint were simply supported. The failure was characterized in terms of “first-leakage” and if observed in terms of “pipe-fracture.” To detect the “first-leakage” point, the piping component arrangement was connected to a water hose that carried water at standard city pressure which is 276 kPa (40 psi) measured pressure. Also, ten potentiometers were used to record the data. One monotonic test and three cyclic tests were conducted for each type of piping component [12]. Fig. 2 gives the force-displacement curve as measured in the case of monotonic loading test. The “first-leakage” point is depicted by the vertical line at 38.58 mm displacement. As seen in this figure, a leakage caused a vertical drop in the force-displacement curve at this value of displacement. The moment–rotation curves as measured at the two flanges, right and left ends, are shown in Fig. 3 and Fig. 4. As in the case of force-displacement curve, the moment–rotation curve at the right-end of the Tee-joint flange also exhibits a vertical drop at the first-leakage, corresponding to a rotation of 0.0814 radians. However, the moment–rotation curve at the left-end of the Tee-joint flange does not exhibit a similar vertical drop. The rotation corresponding to the first-leakage point is identified in this curve by a vertical line. This difference between the left-end and the right-end behavior exists because the first-leakage occurred at the right-end as shown in Fig. 5. The reasons for the first-leakage are identified as bending of pipe ends and the corresponding slippage and rupture of pipe threads. Complex phenomena such as these vary with different specimen and with the location within a given specimen due to difference in manufacturing as well as variation in localized degradation. The particular approach followed in this study and

Fig. 1. Test setup for experiments on threaded Tee-joints conducted at UB.

Laboratory tests were conducted by University at Buffalo, State University of New York (UB) on various kinds of Tee-joint component of sprinkler piping systems [12]. Both, monotonic as well as cyclic loading were considered. Two types of piping material, Black Iron and CPVC, were considered. A total of three different diameter pipe components, 50 mm (2 inch), 25 mm (1 inch) and 20 mm ( $\frac{3}{4}$  inch), were included. In this paper, a detailed discussion is provided on the experimental setup and results for only the 50 mm (2 inch) diameter Black Iron threaded piping Tee-joint because the particular piping system considered in this study from an actual hospital consists of branch lines that are 50 mm in diameter. This piping system does not consist of any 25 mm and
