International Journal of Rock Mechanics and Mining Sciences

Investigation of shaft stability and anisotropic deformation in a deep shaft in Idaho, United States

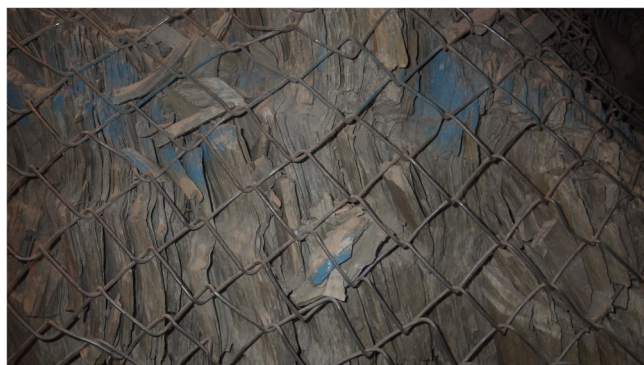
Fig. 1. Photo from the Lucky Friday mine showing the argillite unit through which the #4 shaft was excavated; the kinking of the beds shown in this photo is present in some locations, but is not ubiquitous throughout the unit.

The #4 Shaft was excavated through the thinly bedded argillites of the pre-Cambrian Wallace Formation (see Fig. 1). Due to the presence and persistence of bedding in this unit, its mechanical behavior is highly anisotropic; the bedding orientation is near vertical with a roughly east-west strike, and experience has shown that significantly more damage and deformation is observed in drifts driven parallel to strike than in those driven perpendicular to strike. The argillite

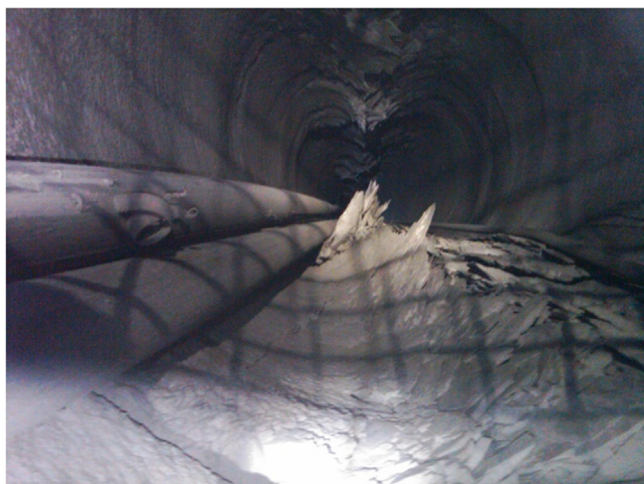
Fig. 2. Example of stress-induced argillite buckling in a raise at the Lucky Friday mine (after⁴).

Based on previous observations made at the Lucky Friday mine, the primary mode of yielding in the argillites was predicted to be time-dependent buckling of the individual laminations at their point of tangency to the shaft; similar behavior had previously been observed in bored raises excavated in the argillite (see Fig. 2).
