Research Paper

Characterization of the fretting corrosion behavior, surface and debris from head-taper interface of two different modular hip prostheses

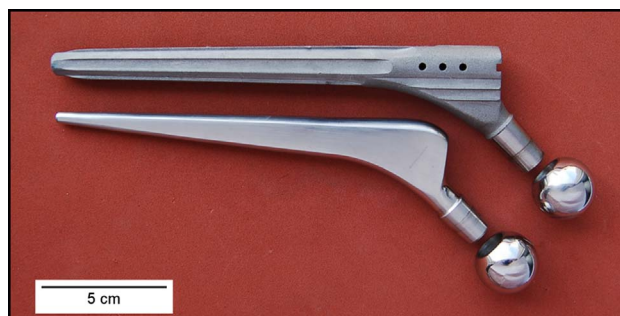
Fig. 1 – Modular hip prostheses: Model SS/Ti Cemented (top) – head made of ASTM F138 stainless steel and stem made of ASTM F136 Ti-6Al-4V alloy; Model SS/SS Cementless (bottom) – head and stem made of ASTM F138 stainless steel.

In the present study two different models of modular hip prostheses were analyzed. Model SS/SS Cemented (Fig. 1, bottom): prosthesis of long term use with the femoral head and stem made of austenitic stainless steel (ASTM F138-13a, *Standard Specification for Wrought 18Chromium-14Nickel-2.5Molybdenum Stainless Steel Bar and Wire for Surgical Implants*) and polished surface finish (body of the stem), indicated to arthroplasty procedure using bone cement. Model SS/Ti Cementless (Fig. 1, top): prosthesis of long term use with the femoral head made of ASTM F138 stainless steel and stem made of Ti-6Al-4V alloy (ASTM F136-13, *Standard Specification for Wrought Titanium-6Aluminum-4Vanadium ELI (Extra Low Interstitial) Alloy for Surgical Implant Applications*) and rough surface finish obtained by blasting (body of the stem), indicated to cementless arthroplasty
