Original article

3D digital documentation for disaster management in historic buildings: Applications following fire damage at the Mackintosh building, The Glasgow School of Art

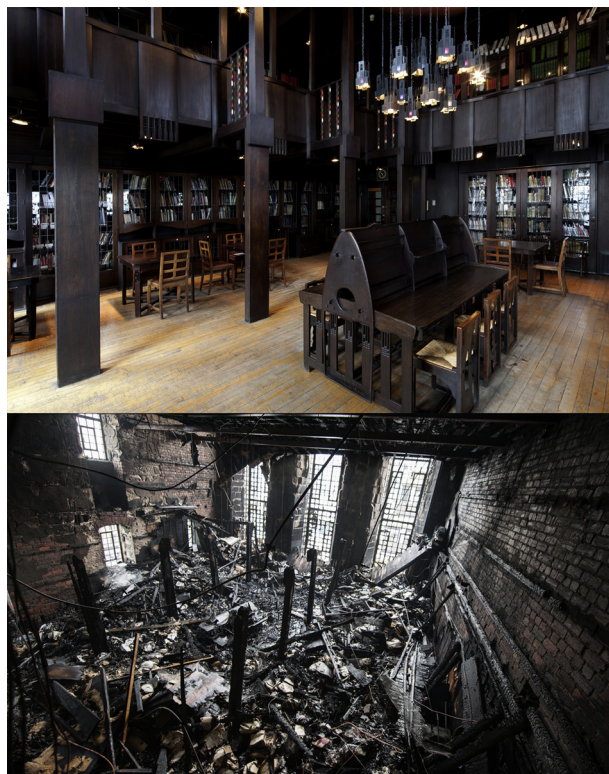
Fig. 1. The Mackintosh building library, before and after the fire on 23rd May 2014. Before image © McAteer, Glasgow School of Art, CC BY-NC-ND 2.0.

phases between 1897–1899 (east wing) and 1907–1909 (west wing). It is widely regarded as an internationally important historic structure and Mackintosh's iconic architectural masterpiece ([3]: 153 and [4]: 1). On 23rd May 2014, fire took hold in the basement level of the west wing and very quickly spread upwards and outwards. There was considerable fire damage, notably to the iconic library (Fig. 1), Mackintosh furniture store, the glazed 'Hen Run' corridor and studios of the western wing. The immediate response from the Scottish Fire and Rescue Service is credited as having saved the building from significantly further destruction ([5]: 5). Following the fire, there has been considerable debate amongst architectural and heritage communities on proposals for reconstruction (e.g. [6]: 26), that has stimulated new research into the architectural history of the building (R. Calvert pers. comm. and [7]), both out of the necessity of conservation efforts and through new discoveries learned through this process.
