Original article

Investigation on the chemical structure and ageing transformations of the cycloaliphatic epoxy resin EP2101 used as stone consolidant

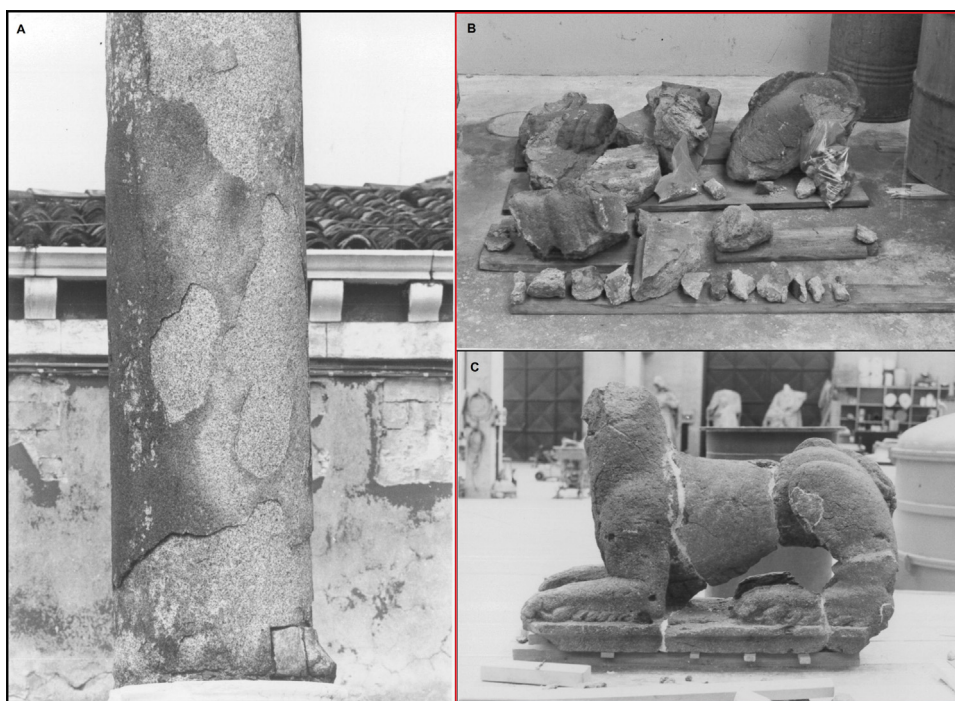
Fig. 1. State of conservation of an ancient Mysian granite column on the Island of Murano before consolidation treatment (A) and the trakyte Gatta di Sant'Andrea in Padua before (B) and after (C) restoration using EP2101.
