MODIHMA 2018

Moisture monitoring experience in the old town of Genoa (Italy)

R. Vecchiattini

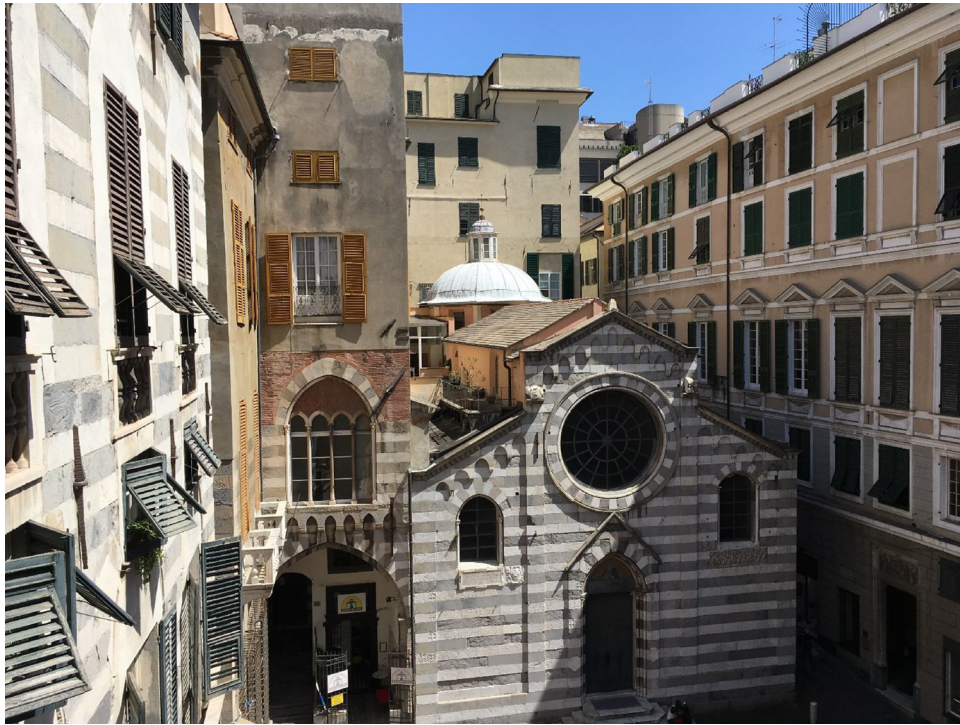
Fig. 1. St. Matteo Abbey in Genoa's old town. The Abbey is surrounded by the houses of the old town, which is also why it is difficult to see its walls and understand the complexity of its humidity problems. In addition to a significant problem of damp rising from the ground—which the present contribution deals with—there are also issues with condensation and infiltration from above. These issues with condensation and infiltration are also linked to a small private terrace above the covering of the left aisle, which complicates the drainage of rainwater.

The Abbey of St Matteo [1,2] is located within a small square in Genoa's old town. The church was built in the thirteenth century by the powerful noble Doria family. The Abbey (Fig. 1) was built in 1278 upon the remains of a previous church (1125) that had been commissioned by a member of the Doria family, but which no longer reflected the growing power of the family. In the first half of the sixteenth century Andrea Doria, a brave admiral, who was extremely influential among the European courts in the Mediterranean, commissioned new important construction work in the Abbey. He appointed Giovanni Angelo Montorsoli to renew the crypt, the chancel and the dome, although, the largest part of the work was executed in the second half of the sixteenth century. Afterwards, Giovanni Battista Castello, known as Bergamasco, and Luca Cambiaso were then appointed to radically renew the design of the Abbey [3]. They decided to significantly widen its volume
