# Studies for the restoration of the Islamic Bofilla Tower as an example of wood use in rammed earth structures

This paper deals with the analysis of traces of wood technology in the Bofilla Tower, a medieval rammed earth Islamic watchtower close to Valencia. Although the principal material constituting the tower is earth, wood played a basic role in the construction and use. Indeed, wooden elements were used to execute the formwork, as reinforcement for the earthen structure and as structural material for the floors. At the time of restoration, the tower had completely lost its floors, ceilings and stairs, although traces of the original structure and small pieces of woodwork remained. Samples of various elements were extracted and anatomically examined in order to identify the timber. Only four types of timber were identified: olive, maritime pine, mulberry, and ash. Based on the few wooden remains found and the tests carried out, this paper analyses the use of different timbers found within the structure of the tower and tries to identify the provenance of the wood according to the organisation of the rural community living around the building. The paper concludes with a descri

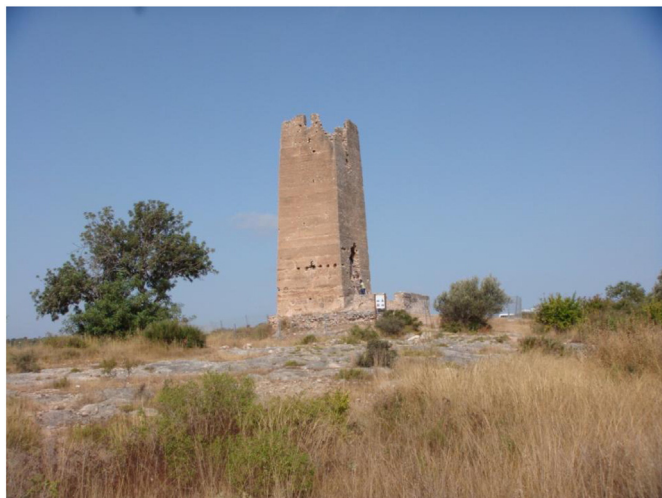
Fig. 1. Bofilla Tower before the conservation work (C. Mileto and F. Vegas).

The Bofilla Tower in Bétera (Valencia) (Fig. 1), near the Spanish Mediterranean coast, is a defensive rammed earth structure erected in the Moorish era in the early 13th century (Bazzana and Guichard, 1978). Together with about forty similar structures, associated with farms, it is part of the protection and sighting system around the city of Valencia during the years of the Christian re-conquest (Rodríguez, 2008). Progressively abandoned in the 15th century, due to wars with the kingdom of Castile, famine and plague epidemics (López Elum,

1994), the Bofilla Tower suffered about five hundred years of neglect and looting. At the time of study, the tower presented material degradation linked to environmental agents (microvegetation and dirt on the surface; erosion and loss of volume on the crowning; erosion due to increased capillary action on the base; washing-off, especially on the upper section of the south façade, etc.) as well as to human action (the removal of the voussoirs from the main door resulted in the major collapse of the north façade and the upper northwest corner) (Fig. 2). Degradation and pathologies, both human and natural, have not erased the information still found on the surface and in the walls which the 2009–2010 restoration project was able to bring to light (Mileto et al., 2011b). In addition, these centuries of abandonment bear witness to the strength of the original building. The Carbon-14 test carried out in 2010 (Villafranca Sánchez, 2010) on samples of

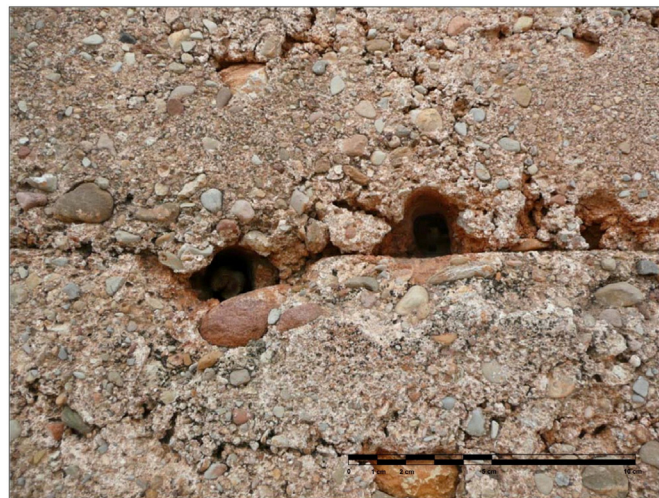
Fig. 3. Putlogs of the formwork inside the walls of Bofilla Tower (C. Mileto and F. Vegas).

beam ends. In addition, these walls still preserved thin putlogs from the formwork and remnants of sleepers and lintels. Therefore, the work aimed to study a miscellaneous repertoire of constructive footprints bound to wood technology and legible thanks to the plasticity of the clay used in the walls, in order to guarantee that the restoration and conservation project for the Bofilla Tower would preserve the original walls and all the wooden remains and the construction elements which were of great historical and cultural value. At the same time, the identification of these imprints in the walls (Warren, 1999; Mileto, 2010), together with the analysis of wooden fragments identified in situ, have helped to improve the knowledge of the construction of earthen structures and have ensured the reconstruction of the history of the building location (GPS: lat. 39.580124, long. −0.429165), inextricably linked to the life and history of the rural community that lived around the tower, through the materials found.

wood from the putlogs of the formwork of the rammed earth revealed that these elements were approximately  $750 \pm 60$  years old, indicating that the Tower could have been built between 1200 and 1320. These dates were cross-referenced with the historical data on the Christian conquest of these territories in 1238, as this would have been the last possible date of construction for an Islamic tower, as well as with the ceramic fragments found in the course of the excavation (Burriel and Ruiz, 2009). This suggests that the tower was built between 1210 and 1220 CE.

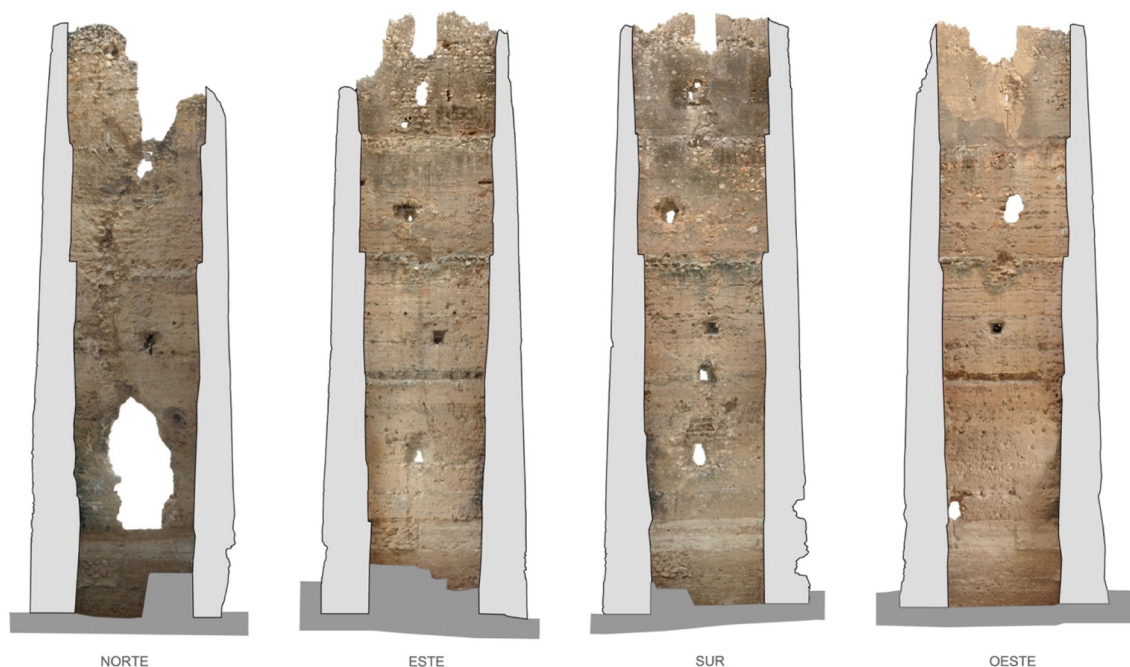
Fig. 2. Bofilla Tower, inner sections, before the conservation work (C. Mileto and F. Vegas).

The sides of the square tower are 6.15 m, reduced to 5.20 m at the crown, so that the profile is that of a truncated pyramid. The walls are up to 1.20 m thick at the base of the tower but the external tapering and the internal staggering of the wall reduce this to 56 cm in the upper part. The survey suggests that the tower was probably built by
