11th International Conference Interdisciplinarity in Engineering, INTER-ENG 2017, 5-6 October 2017, Tirgu-Mures, Romania

Ballast bed cleaning and recycling – influence on stability of continuously welded rail track

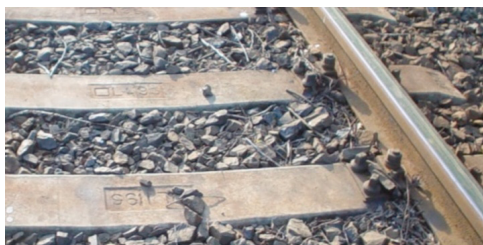
Fig. 1. Fouled ballast.

Fouling materials can be dust, coal, fine particles from ballast degradation, clay as the result of pumping of the sub grade, having both beneficial and adverse effect on fouled ballast, the result depends on the types of fouling material present, the degree of fouling and the water content. Before the ballast particles lose their contact, the ballast bed still preserves his stiffness, the result being an increase of the normalized shear force modulus. In cases of highly fouled ballast, with large amount of impurities, the particles will lose their contact with one another, as a result of ballast particles reorientation upon the cyclic loading and sliding effect due to impurities [5, 6].
