Vibration measurement-based simple technique for damage detection of truss bridges: A case study

Sudath C. Siriwardane*

University of Stavanger, Department of Structural & Mechanical Engineering and Material Science, Stavanger N-4036, Norway

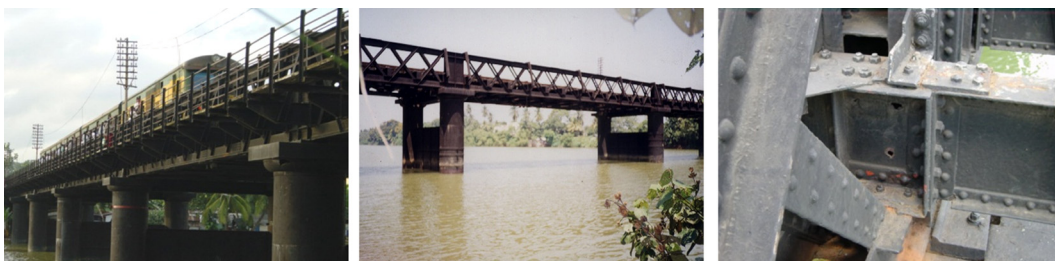
Fig. 1. General views of the riveted railway bridge.

The selected bridge is a railway bridge spanning 160 m as shown in Fig. 1. It is a six span-riveted bridge with double lane rail tracks having warren type semi through trusses, supported on cylindrical piers. The bridge deck is made of wrought iron and the piers are made of cast iron casings with infilled concrete. The bridge was constructed in 1885. Details of trains carried by the bridge and their frequencies illustrate that the bridge is experienced variable amplitude fatigue loading.

The condition survey revealed that some places of the bridge have been subjected to mild corrosion due to the absence of anti-corrosive coating (refer Fig. 1). No visual cracks were observed in any component of the super structure. In situ measurements of member sizes, connections and support bearings verified the fact that the existing drawings were applicable and only few significant variations were observed. The visual inspection was done in year 2001.
