Analysis of the failure of primary support of a deep-buried railway tunnel in silty clay

This paper analyses the mechanism for the failure of primary support of a deep-buried tunnel whose side wall collapses during construction. The main focus is on discussion and comparison of the soil engineering aspects of the incident, and on the lessons that may be learnt from the case. Empirical and numerical analysis have been carried out for the collapse. The mechanisms of failure of tunnel are analyzed during tunnel excavation and the parameters of support are revised according to the results of analysis. Results have shown that the collapse of tunnel is mainly attributed to abundant joint fissures on surrounding soil. The changed support makes tunnel drive through the section of collapse successfully, and similar dangerous situation does not take place in the following construction.

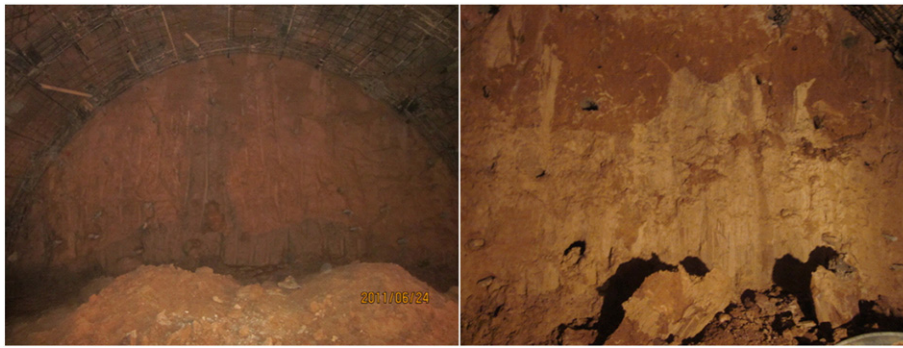
Fig. 1. Geo-condition in the section of collapse (tunnel face).

Yang Jialing tunnel is driving through silty clay, fine gravel soil, coarse gravel soil and mudstone. Starting from DK27 + 260, silty clay is met with anisotropic geomaterials and lens, such as thick pellet soil, sand and ginger like stone, accompanied by tight tectonic joints with strike parallel to the tunnel axis and dip angle approximate to 90°. The detailed geological condition is showed in Figs. 1 and 2.
