# Experimental studies of the seismic behavior of double-layer lattice space structures I: Experimental verification

Chen-xiao Zhang<sup>a,b</sup>, Gui-bo Nie<sup>a,b,\*</sup>, Jun-wu Dai<sup>a,b</sup>, Xu-dong Zhi<sup>c</sup>

<sup>a</sup> Institute of Engineering Mechanics, China Earthquake Administration, Harbin 150080, China

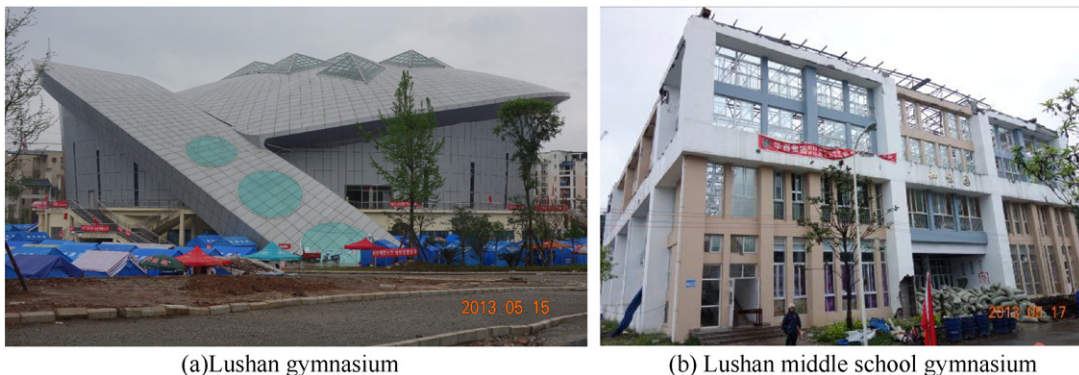
**Fig. 1.** Appearance of Lushan gymnasium and Lushan middle school gymnasium after the earthquake. (a) Lushan gymnasium. (b) Lushan middle school gymnasium.

The M7.0 Lushan earthquake occurred on April 20, 2013, resulting in 196 people dead, 24 missing and at least 11,826 injured, with more than 968 seriously injured. Four double-layer lattice space structures were found in a state of damage. Two of them, Lushan gymnasium and Lushan middle school gymnasium, suffered severe damage, and the latter structure was rendered unusable. Some typical failure patterns of the two structures were investigated during this earthquake, which was different from previous earthquakes in China, and even in the world. The Lushan gymnasium and Lushan middle school gymnasium were built after the 2008 M8.0 Wenchuan earthquake, which occurred on the same province of China. The damage of these
