Numerical and experimental failure analysis of rifle extractor

Jerzy Malachowski^{a,*}, Krzysztof Damaziak^a, Paweł Platek^b, Marcin Sarzynski^b,
Przemysław Kupidura^b, Ryszard Wozniak^b, Mirosław Zahor^b

The purpose of this article is to present a research methodology used to determine the causes of mechanical damage of a cartridge case extractor in a newly designed 5.56 mm assault rifle. It combines numerical analyses and materials science research. Based on the results obtained through simulation studies utilizing the Finite Element Method, values of local stress concentrations in the case extractor were identified. The paper provides detailed information on the used numerical models and adopted initial-boundary conditions required to carry out computer simulations. Based on the obtained values of maximal principal stress, the authors decided to carry out additional experimental research in order to reveal the cause of extractor damage. An adopted approach was consisted of micro hardness and metallographic analysis of the images depicting the microstructure of the extractor material. There were not observed any negative effects of an extractor heat treatment process on mechani

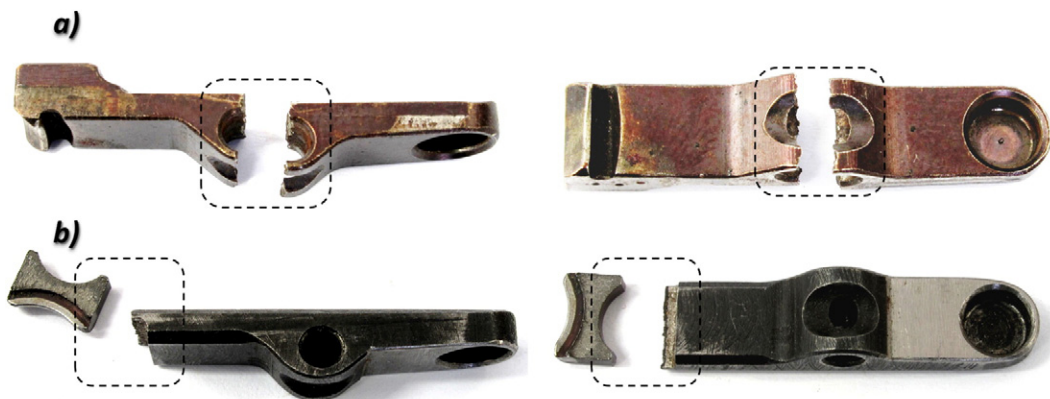
Fig. 1.1. The main view of MSBS extractor failures occurred during firing.
