Engineering Failure Analysis

Investigation into the causes of fracture in railway freight car axle

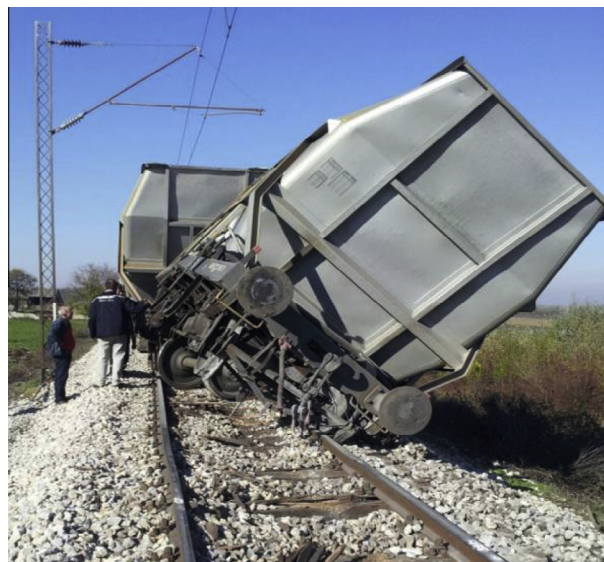
The freight car for coal transportation from the mine to the thermal power plant has two axles. The failure has taken place on an industrial gauge used for coal transport, as shown in Fig. 1. Under exploitation conditions nominal axle load amounts to 200 kN, while railway car speed of motion is up to 70 km/h. The stopping and braking of railway car is done by brake shoes. Accordingly, under exploitation conditions, the axle is bending stressed only.

Fig. 1. Appearance of damaged railway car.
