# Effects of fire on precast members: A case study

Mehmet M. Kose \*, Huseyin Temiz, Hanifi Binici

A cotton thread plant located in Kahramanmaraş, Turkey was burned down in 2003. During the fire, the plant was used as a storage space for cotton fibers and waste. The plant was constructed by precast concrete structural members in 1997 and its construction area was 8142 m<sup>2</sup>. Riverbed aggregate and Portland cement was used in the production of concrete. Compressive strength of concrete was 25 MPa. All precast structural members had 1.5 cm concrete cover. Roof covers made by aluminum panels. In the plant, there were no interior walls and all the exterior walls were made by hollow clay bricks and plastered. There was no protection against fire in all precast concrete structural members. The construction was heavily damaged and collapsed. The estimated loss of goods was around \$6,000,000.

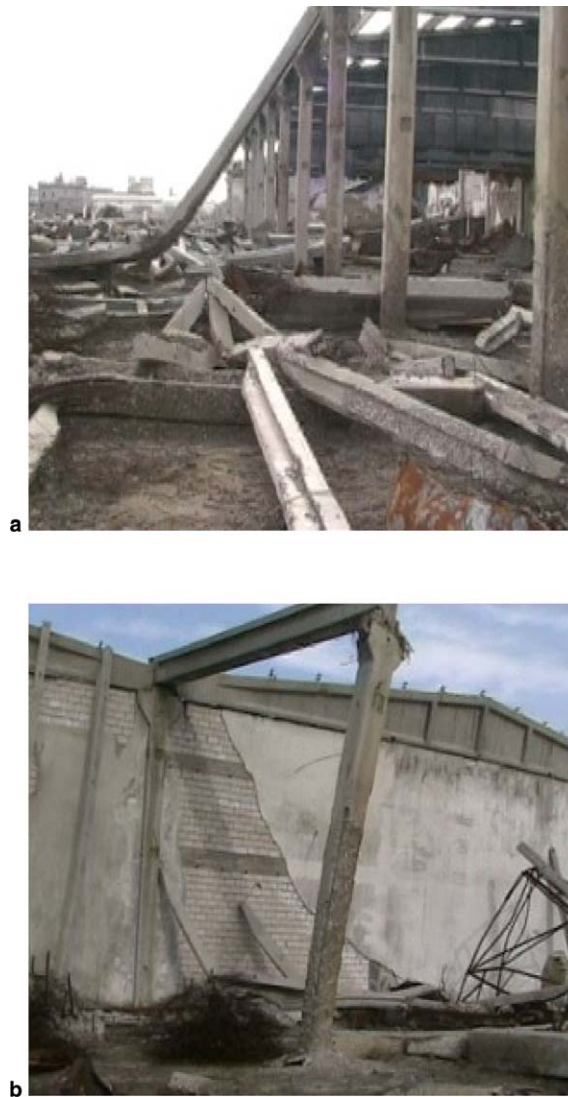
Fig. 1. General view of plant after fire: (a) collapsed structural members and (b) deformed column and beam.

In this study, a cotton thread plant in Kahramanmaraş, Turkey, which was burned in 2003, was investigated. The plant was constructed by precast concrete structural members in 1997 and its construction area was 8142 m<sup>2</sup>. General view of the plant after the fire was shown in Fig. 1.
