## A study on axial cracking failure of drill pipe body

Frequently happening drill pipe failure accidents in oil and gas wells not only affect drilling speed, but cause enormous economic losses and many safety issues. Most of these accidents are transverse cracking of drill pipe body and pin thread or axial cracking of box thread. Based on the axial cracking failures of drill pipe body in an ultra-deep well in China, this paper give a systematic analysis of axial cracking failure in consideration of service condition, material quality and stress corrosion mechanism. Measurement and inspection are performed on macroscopic and microscopic morphology of crack surface, corrosion products and circumferential residual stress. Then stress corrosion cracking experiments against hydrogen sulfide is conducted. Finally, the critical stress value for sulfide stress corrosion cracking of the drill pipe material is obtained, and the mechanisms of axial cracking failure and corresponding preventive measures are proposed.

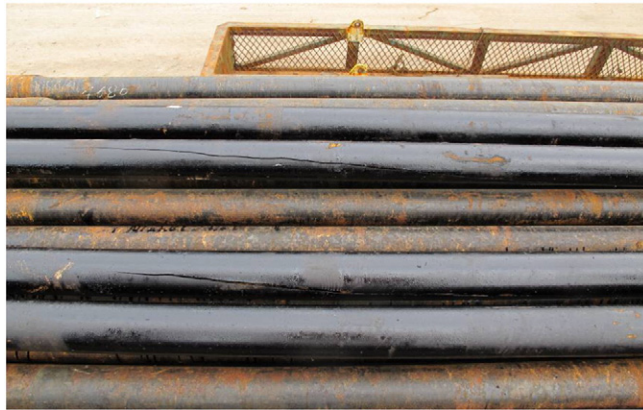
Fig. 1. Visual inspection of axial cracking drill pipes.

In the drilling process of an ultra-deep well, axial cracking failures took place on several drill pipes, as shown in Fig. 1. In order to clarify the mechanisms of drill pipe axial cracking and corresponding causes, this paper carried out a series of experiments and analysis.

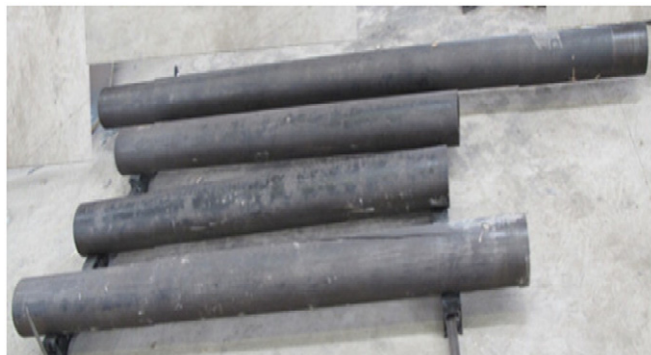
Fig. 2. The drill pipe specimens.

Many 5 7/8 in.  $\times$  0.43 in. drill pipes with S135 steel grade failed due to axial cracking. Based on the collected data, H<sub>2</sub>S was detected in the mud circulated from bottom hole and the highest concentration of H<sub>2</sub>S was 200 ppm at wellhead. Fig. 2 shows the macro-morphology of failed drill pipe specimens. All these specimens had undamaged internal coating and no obvious corrosion pit or mechanical damage was observed on pipe surface.
