# Seismic behaviour of reinforced concrete shear walls with regular and staggered openings after the strong earthquakes between 2009 and 2011

Mosoarca Marius\*

*"Politehnica" University Timisoara, 2A, Traian Lalescu Street, Timisoara, Romania*

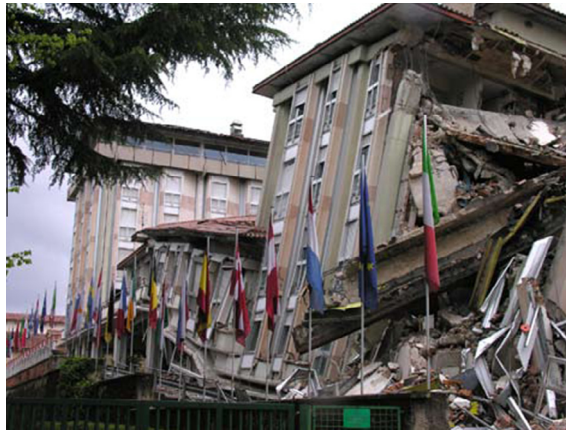
**Fig. 1.** Collapse of part of the Duca D'Abruzzi Hotel, L'Aquila, 2009 [1].

Various buildings collapsed, among which we name: the Duca D'Abruzzi Hotel from L'Aquila (Fig. 1) [1], the Alto Rio residential building from Concepcion, Chile (Fig. 2) [2], the Pyne Gould Cooperation office building from Christchurch, New Zealand (Fig. 3) [3], the school from Gedikbulak, Van, Turkey (Fig. 4) [4].

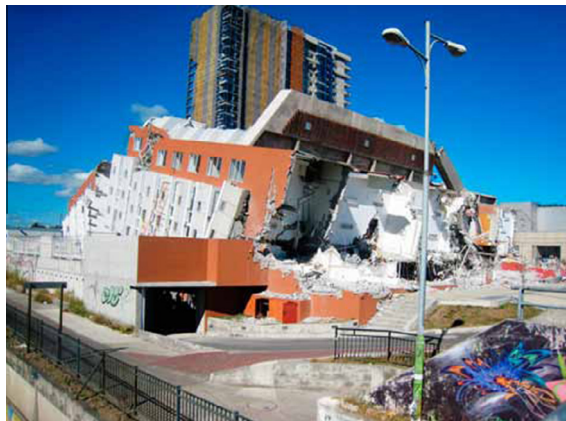
**Fig. 2.** Collapsed Alto Río tower, conception, Chile, 2010 [2].

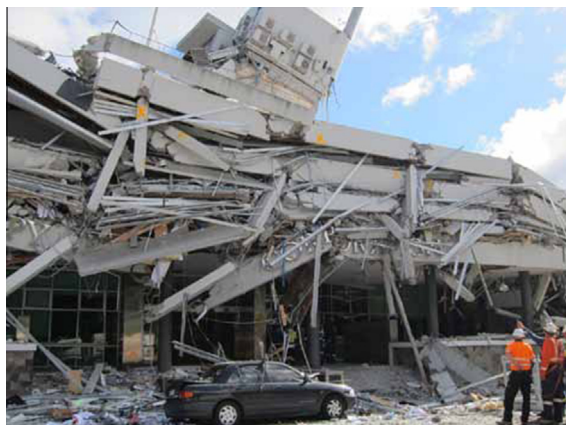
**Fig. 3.** Collapsed Pyne Gould cooperation PGC building, Christchurch, New Zealand, 2011, [3].
