## Case study of masts damage of the sail training vessel POGORIA

Janusz Kozak<sup>a,\*</sup>, Wiesław Tarełko<sup>b</sup><sup>a</sup> Faculty of Ocean Engineering and Ship Technology, Technical University of Gdansk, Narutowicza 11/12, 80-233 Gdansk, Poland<sup>b</sup> Department of Engineering Sciences, Gdynia Maritime University, Morska 81-87, 81-255 Gdynia, Poland

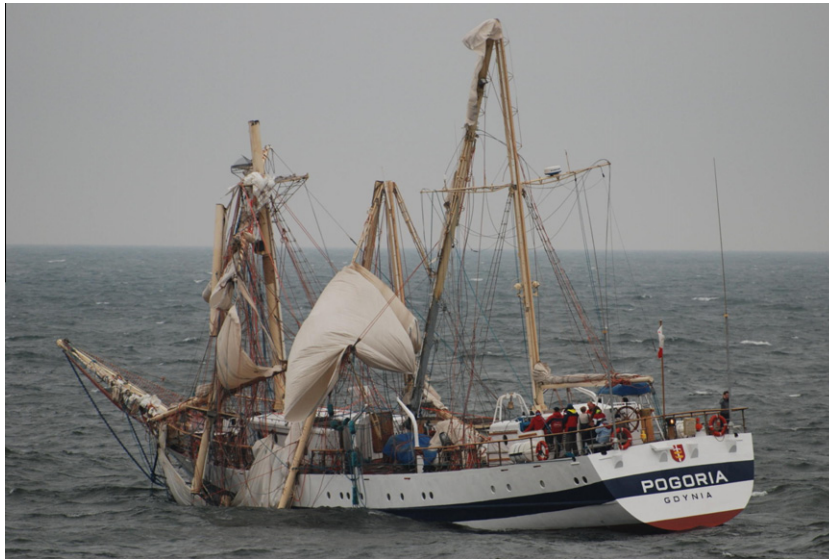
**Fig. 1.** A snapshot of “Pogoria” made just after the accident.

At the entrance to the Gulf of Finland (the Baltic Sea), a Polish barquentine Pogoria with 50 crewmembers onboard had an accident during Tall Ships Race in the first half of July 2009. All three masts were broken and destroyed both the running and standing riggings (Fig. 1). Any significant consequences for the crewmembers did not come into existence.
